# RISK MANAGEMENT REPORT

<b>TYPE</b>	Loader, Wheel
<b>MAKE</b>	Caterpillar
<b>MODEL</b>	980
<b>SERIAL NUMBER</b>	MK910371

<b>Report Number</b>	WILL 20260315-1323
<b>Date</b>	15-Mar-2026
<b>Assessment Purpose</b>	Sale
<b>State</b>	TAS
<b>Created By</b>	Matthew Knowles
<b>Owner</b>	New Equipment - Tasmania
<b>Assessor</b>	Matthew Knowles
<b>Assist. Assessor(s)</b>	
<b>Completed By</b>	Matthew Knowles
<b>Machine Hours</b>	3
<b>Customer Name</b>	FEILDWICKS

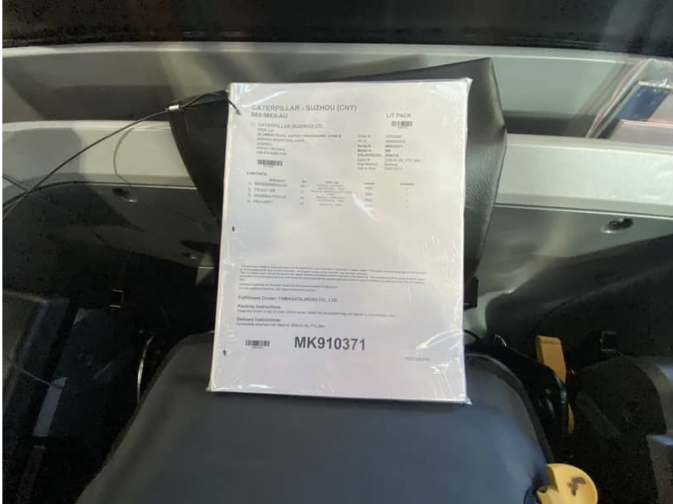
OPERATION AND MAINTENANCE MANUAL

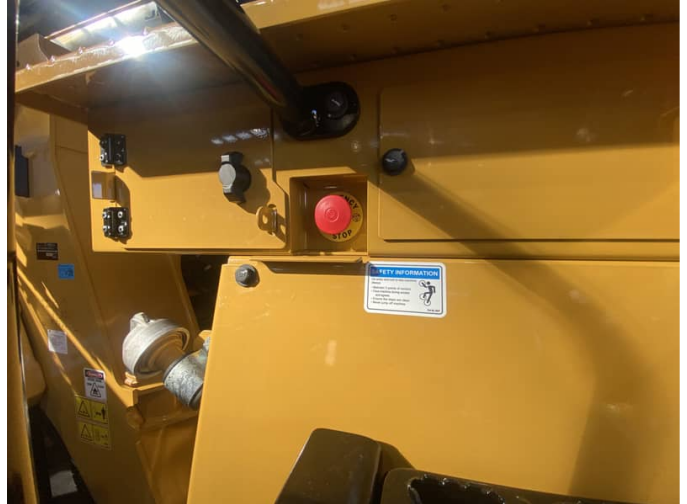
THREE POINTS OF CONTACT DECAL

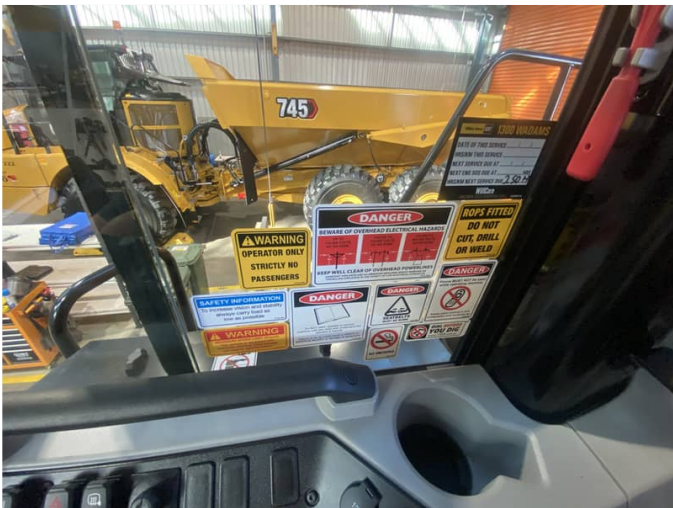
OPERATOR ONLY STRICTLY NO PASSENGERS, BEWARE OF OVERHEAD POWERLINES, NO USE OF MOBILE PHONES WHILST OPERATING AND DIAL BEFORE YOU DIG DECALS

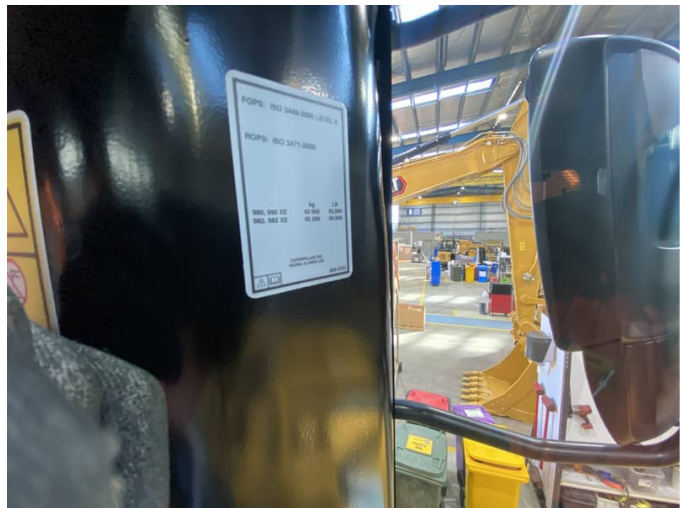
ROPS AND FOPS ISO DECAL

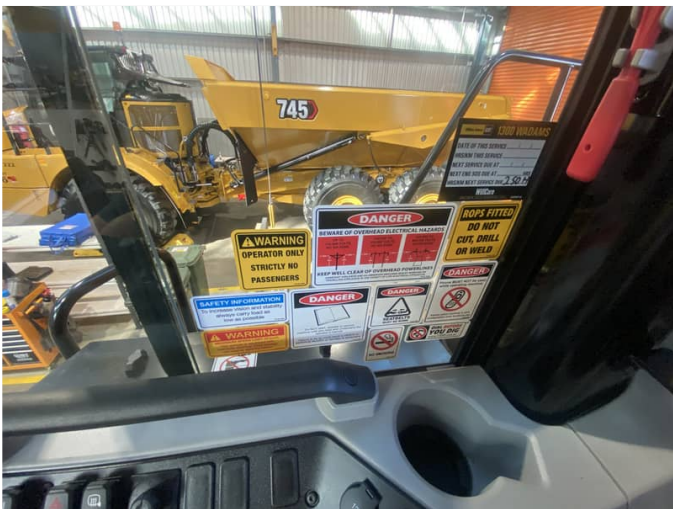
SEAT BELT MUST BE WORN DECAL

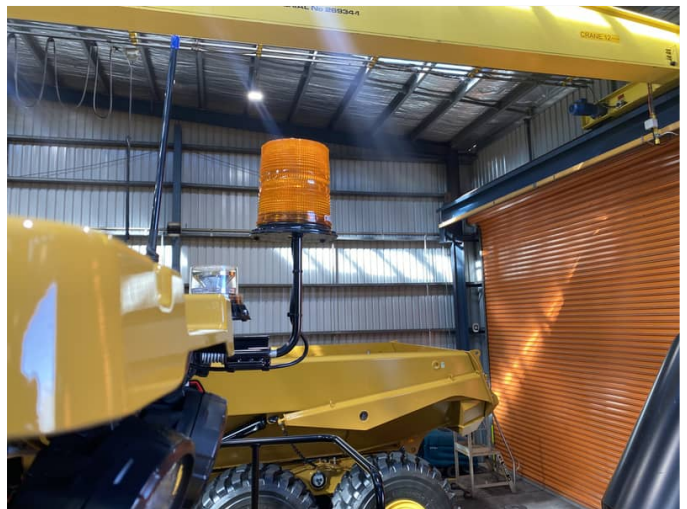
ROTARY BEACON

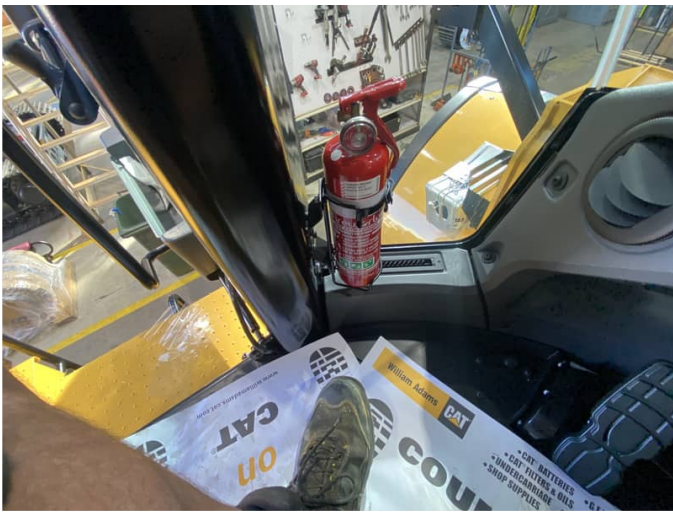
1 KG IN CABIN FIRE EXTINGUISHER

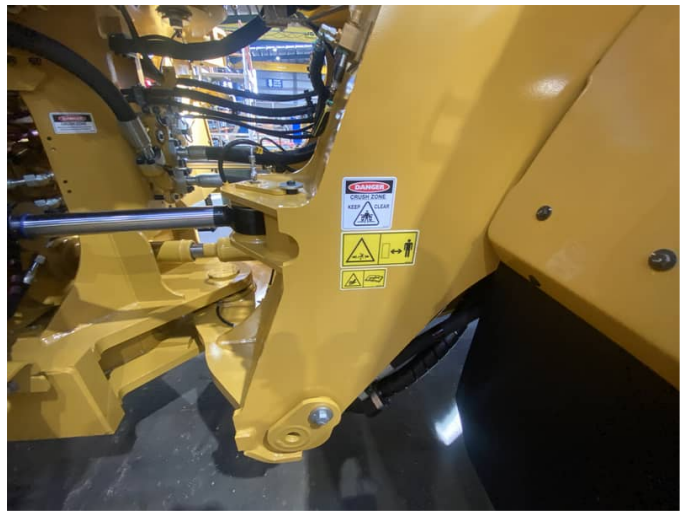
KEEP CLEAR OF ARTICULATION JOINT DECAL

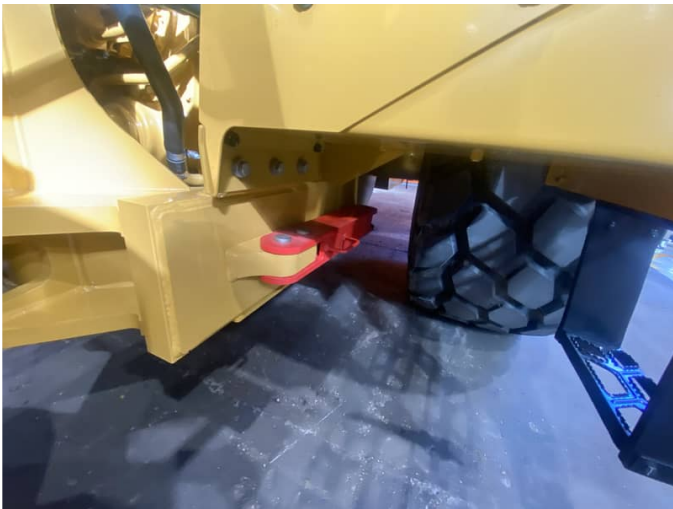
ARTICULATION LOCK

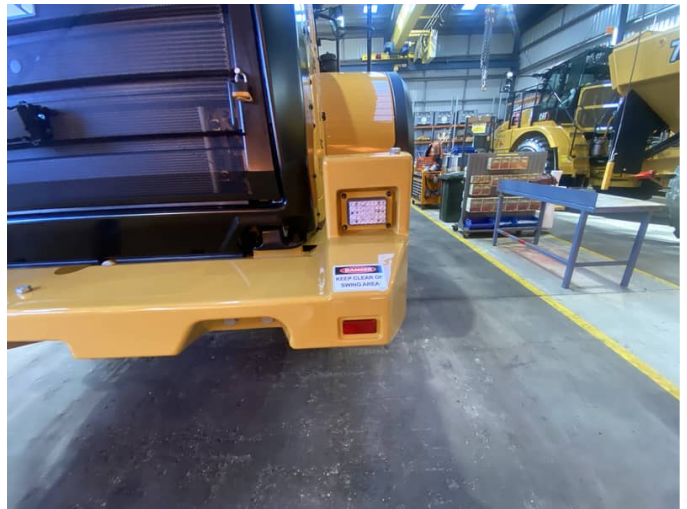
KEEP CLEAR OF TAIL SWING DECAL

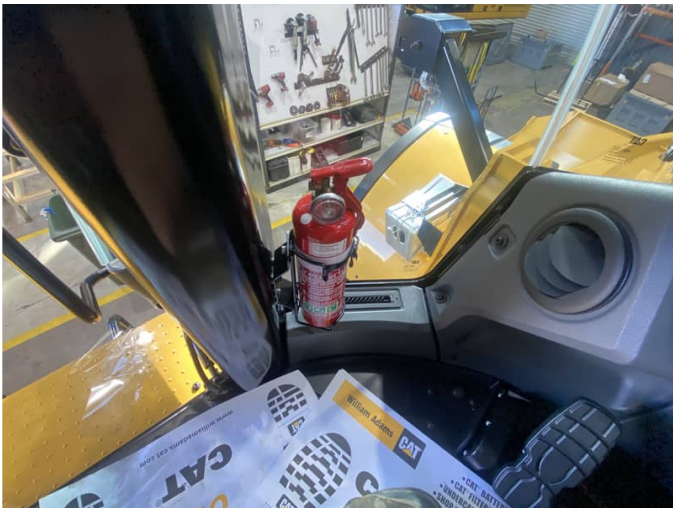
MODIFICATION: 1KG FIRE EXTINGUISHER

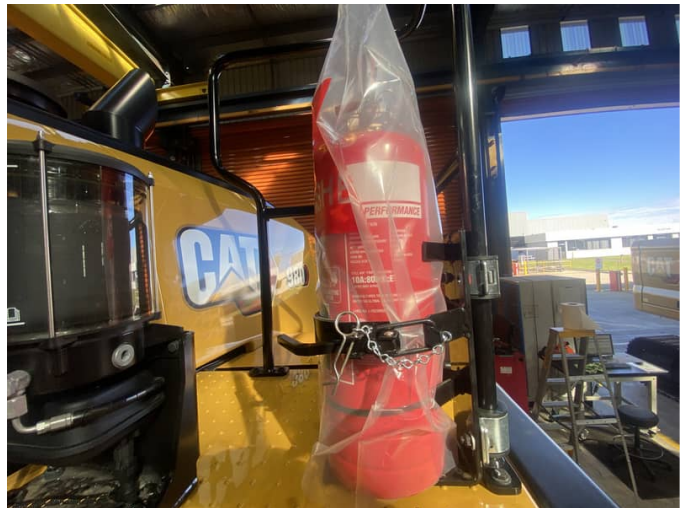
MODIFICATION: 9KG FIRE EXTINGUISHER

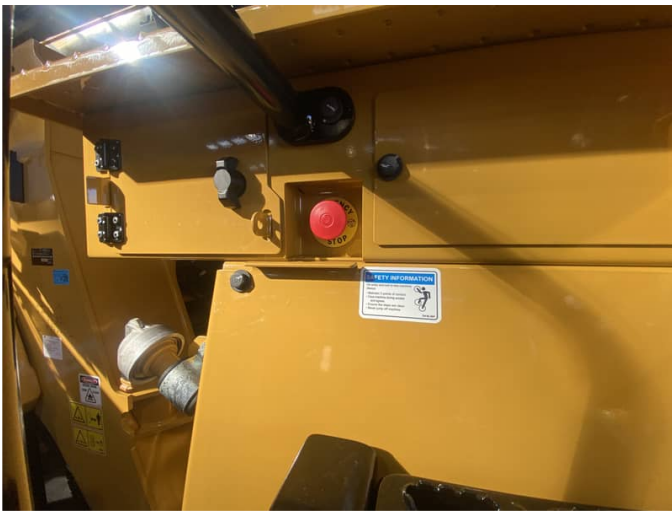
MODIFICATION: ON SIDE GROUND LEVEL SHUTDOWN

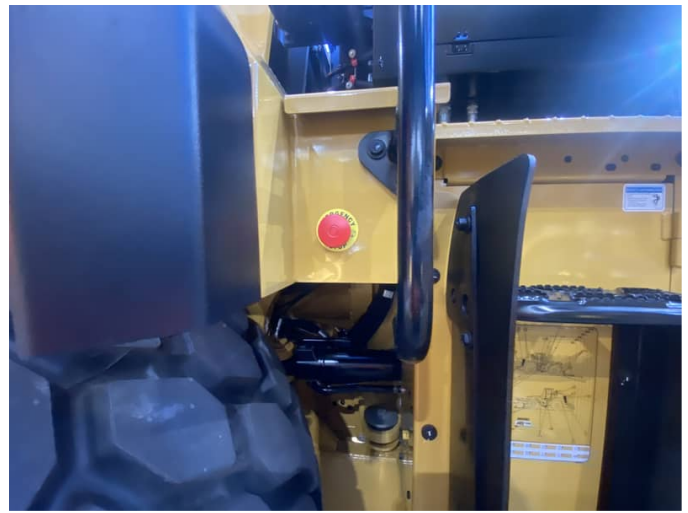
MODIFICATION: OFF SIDE GROUND LEVEL SHUTDOWN

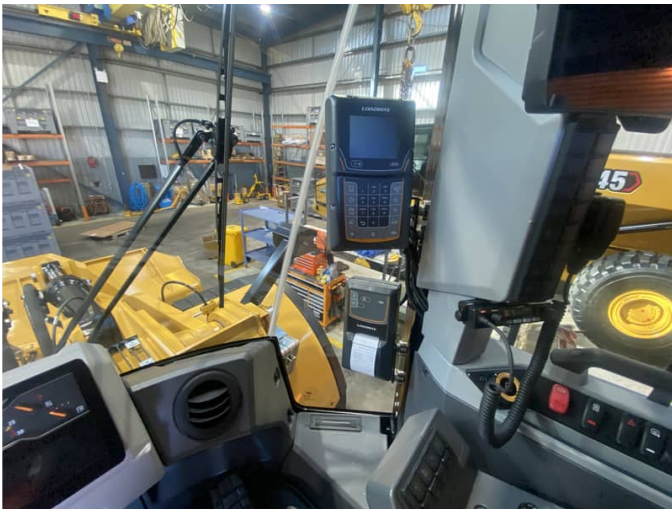
MODIFICATION: LOADRITE SCALE SYSTEM

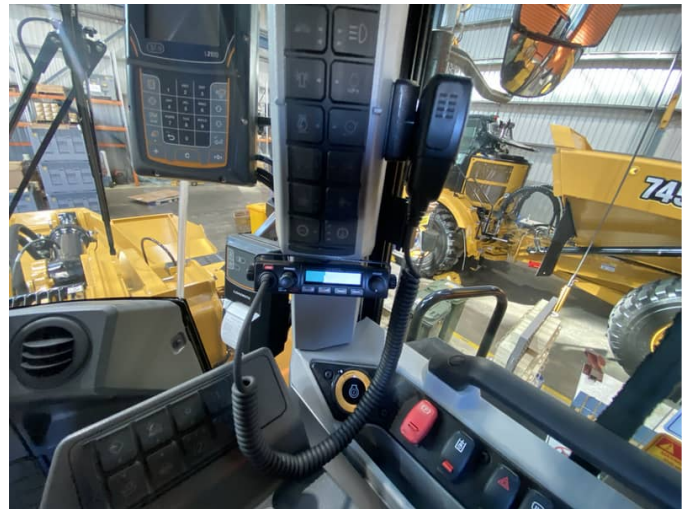
MODIFICATION: TWO WAY RADIO

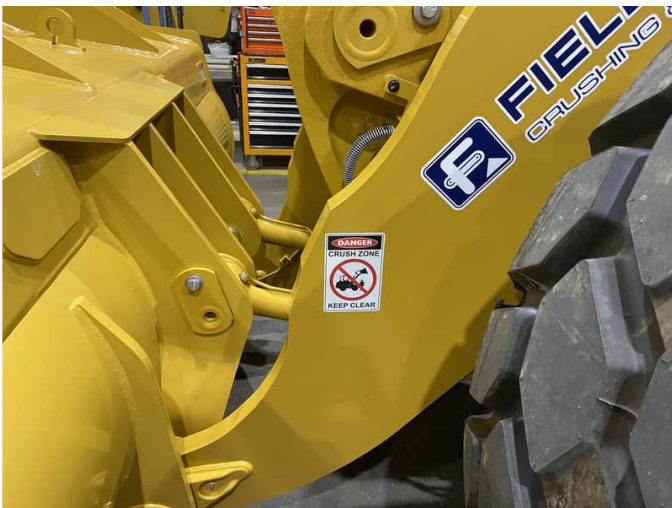
KEEP CLEAR CRUSH ZONE ON LOADER ARMS DECAL
