TYPE	Excavator - Large (20 Tonne +)
MAKE	Caterpillar
MODEL	330 Next Gen
SERIAL NUMBER	KEL21090

Report Number	WILL 20220123-0947
Date	23-Jan-2022
Created By	Matthew Knowles
Assessor	Matthew Knowles
Assist. Assessor(s)	
Completed By	Matthew Knowles
Owner	New Equipment - Tasmania
Machine Hours	4
Assessment Purpose	Sale
State	TAS

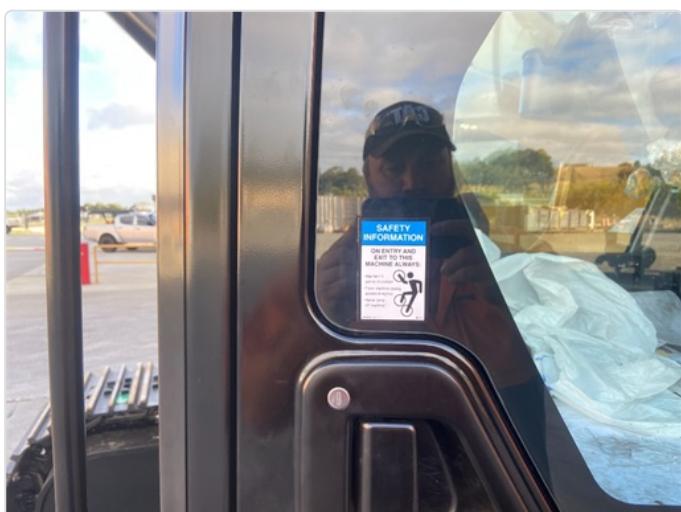
THREE POINTS OF CONTACT ON CABIN DECAL.

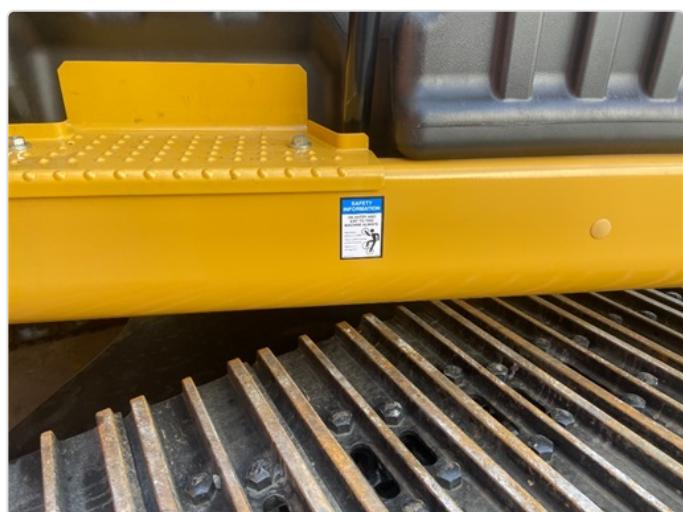
THREE POINTS OF CONTACT OFFSIDE DECAL.

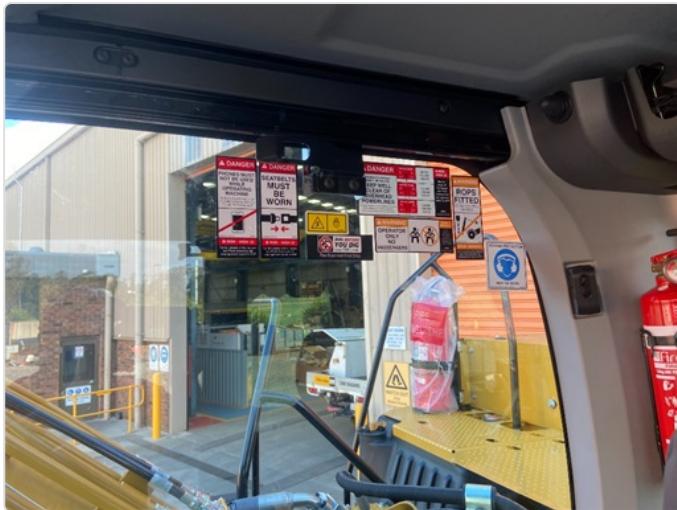
NO PASSENGERS, OVERHEAD ELECTRICAL AND DIAL BEFORE YOU DIG DECALS.

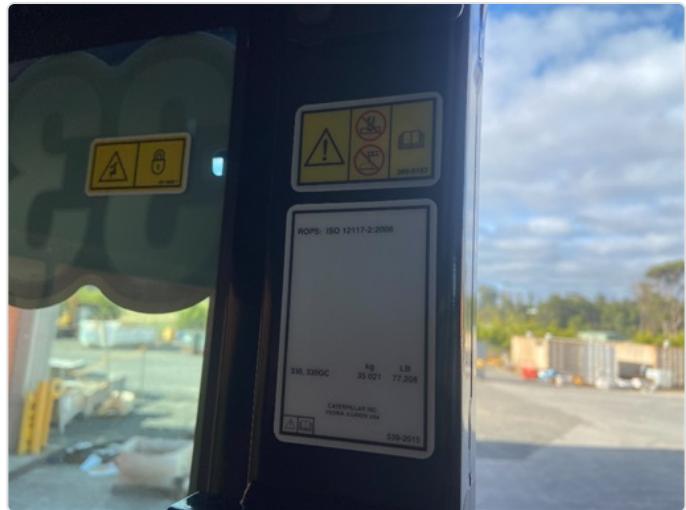
ROPS ISO DECAL.

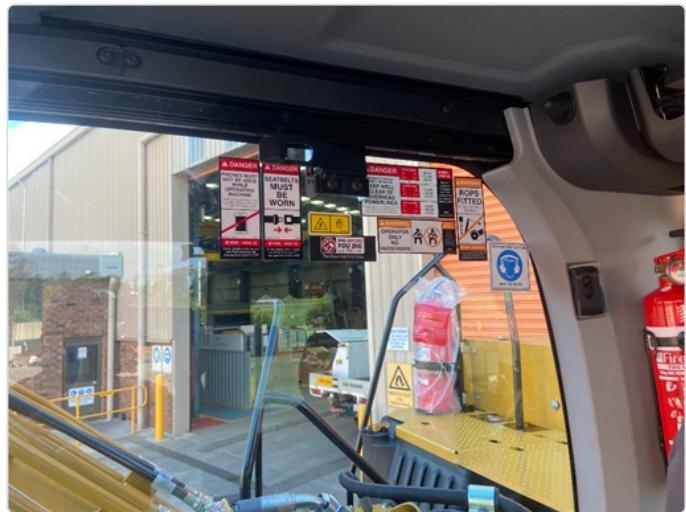
SEAT BELT MUST BE WORN DECAL.

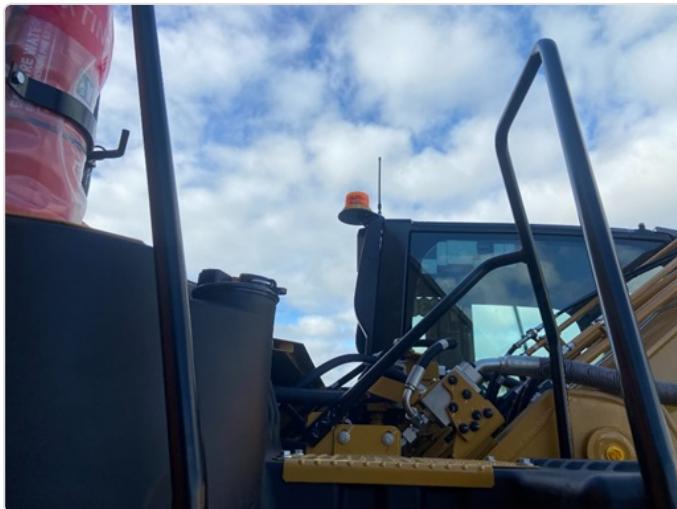
BEACON LIGHT INSTALLED.

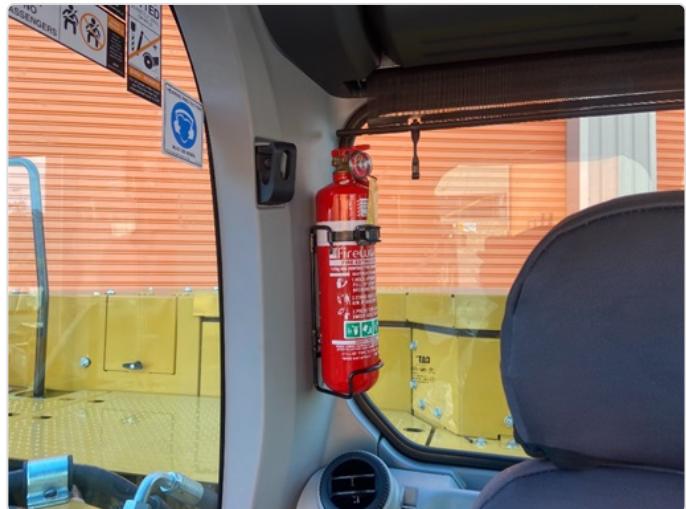
1 KG FIRE EXTINGUISHER.

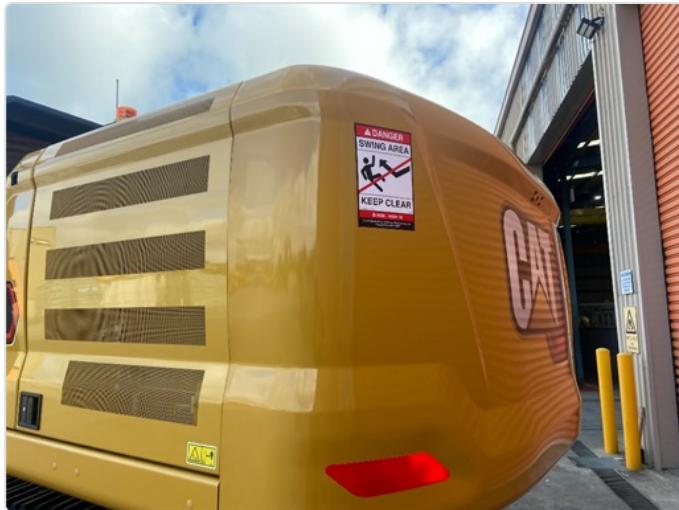
KEEP CLEAR OF SWING DETAILS.

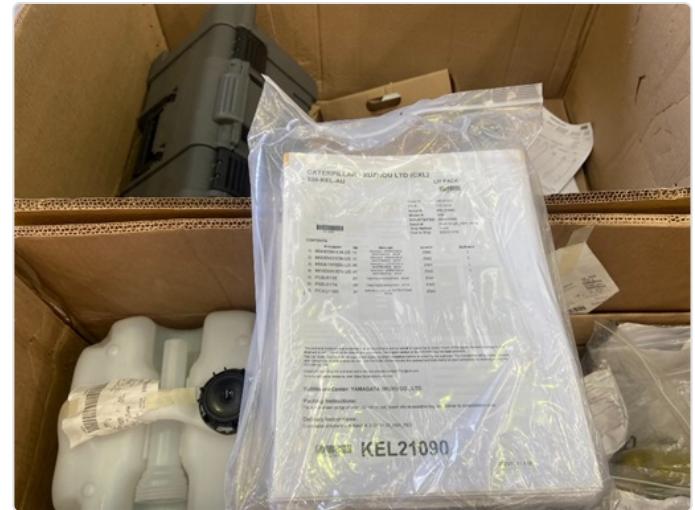
OPERATION AND MAINTENANCE MANUAL.

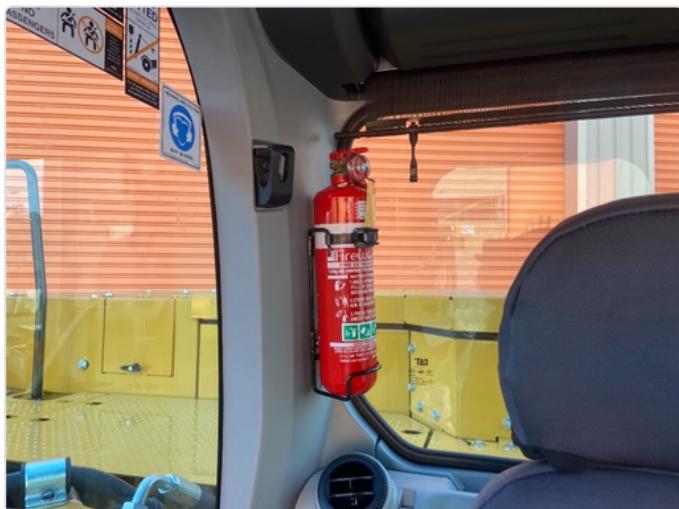
1 KG FIRE EXTINGUISHER

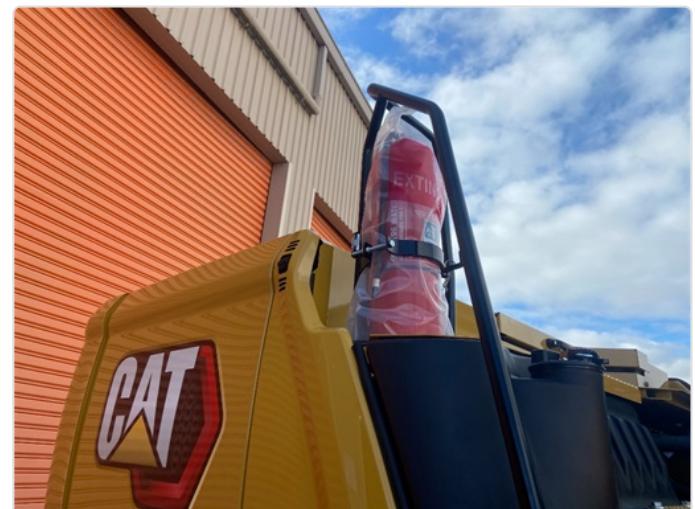
9KG FIRE EXTINGUISHER

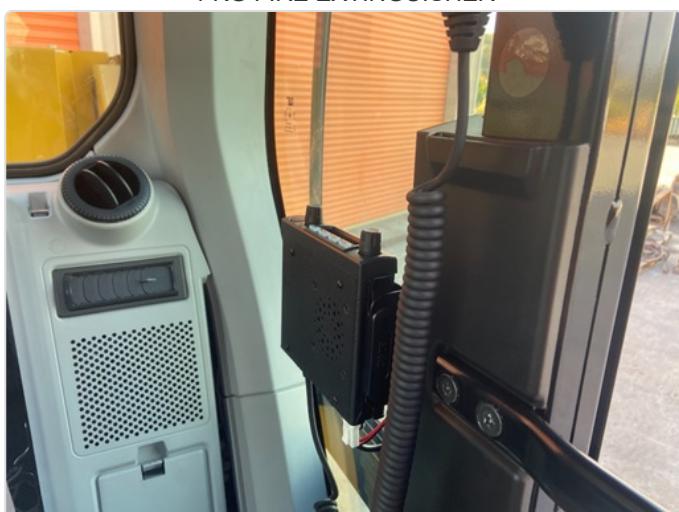
UHF RADIO

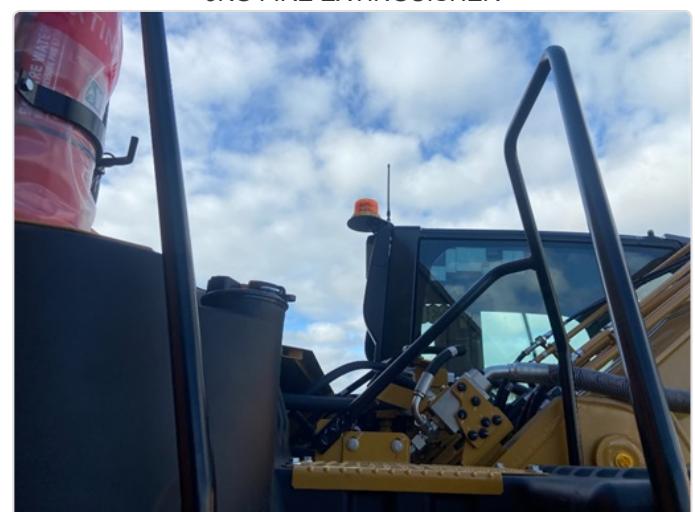
BEACON LIGHT

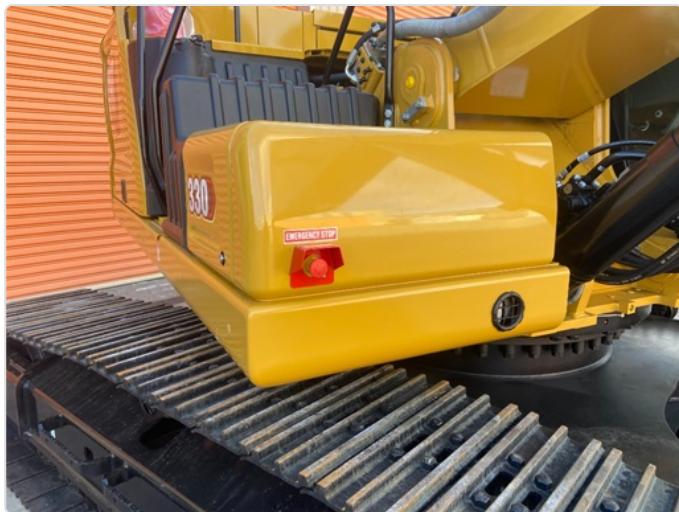
GROUND LEVEL E STOP
