<b>TYPE</b>	Loader, Wheel
<b>MAKE</b>	Caterpillar
<b>MODEL</b>	966GC
<b>SERIAL NUMBER</b>	0SGW00591
<b>ENGINE NUMBER</b>	NTB09523

<b>Report Number</b>	WILL 20211206-1307
<b>Date</b>	06-Dec-2021
<b>Created By</b>	Scott Sandman
<b>Assessor</b>	Scott Sandman
<b>Assist. Assessor(s)</b>	David Coward
<b>Completed By</b>	Scott Sandman
<b>Owner</b>	William Adams Assets
<b>Plant Number</b>	N/A
<b>Machine Hours</b>	12
<b>Assessment Purpose</b>	Sale
<b>State</b>	TAS

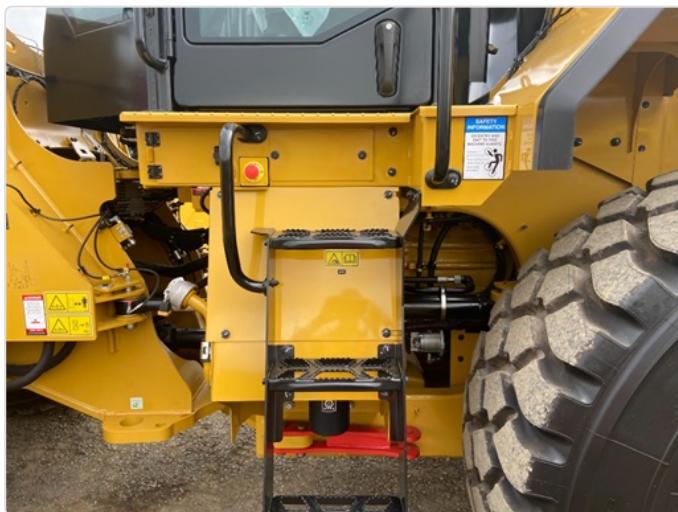
Cab access steps and grab rails L/H

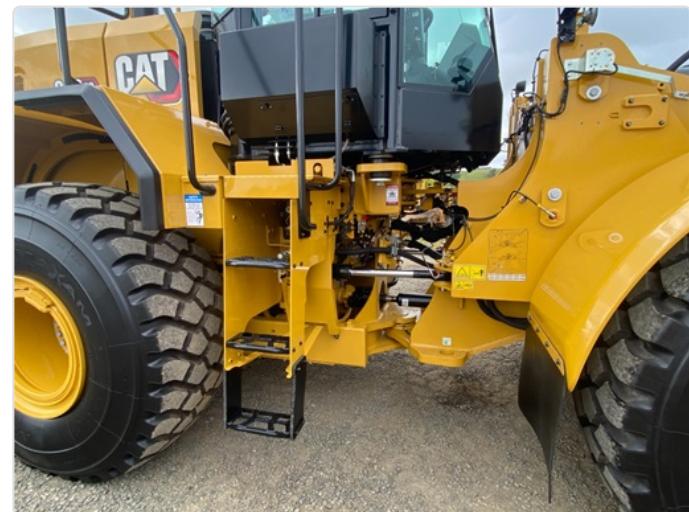
Cab access steps and grab rails R/H

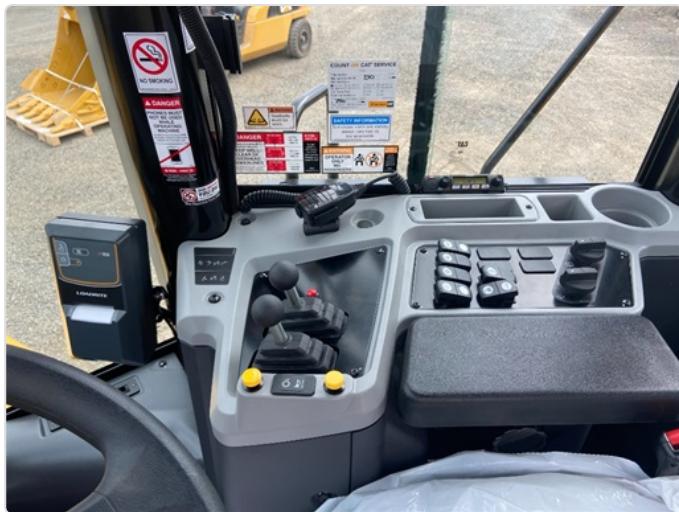
Operator controls

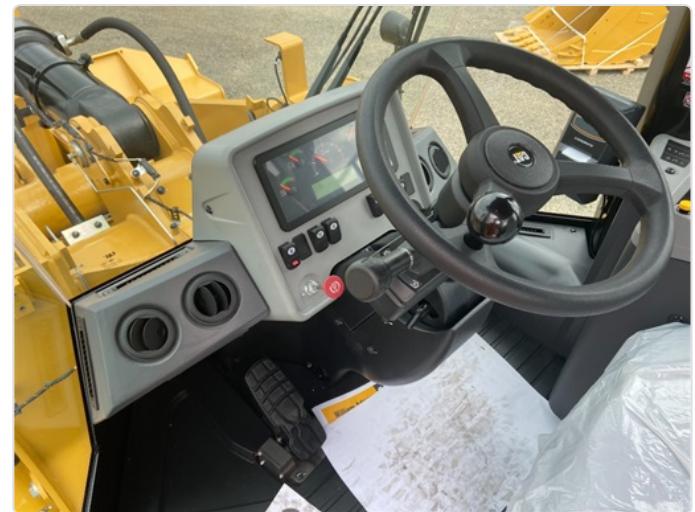
Operator controls

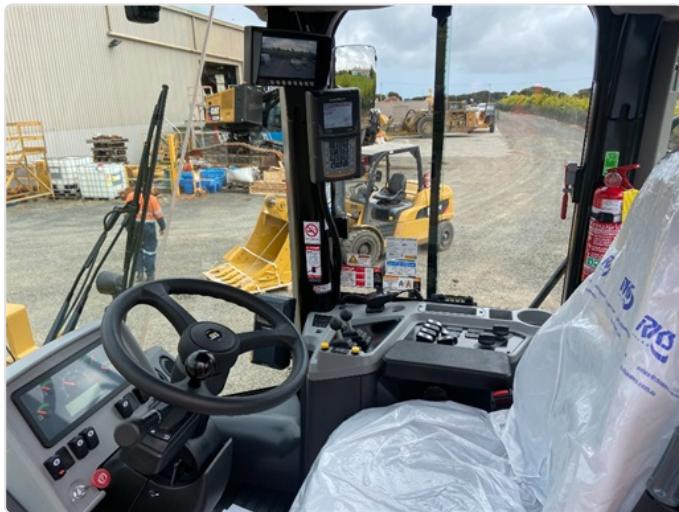
Safety decals in cab

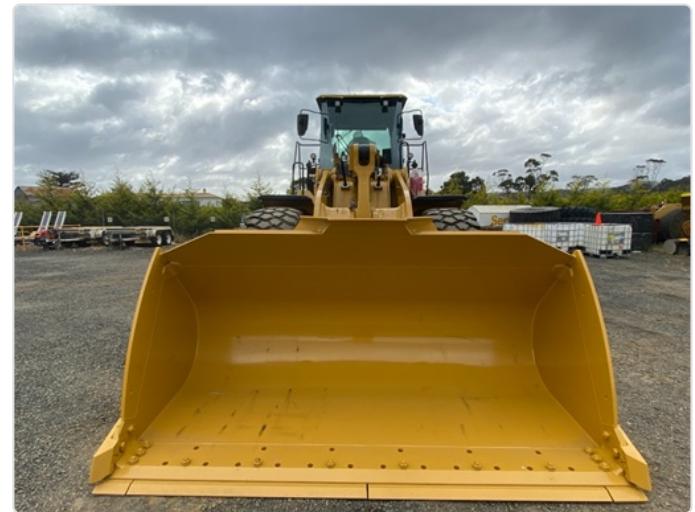
Front lighting

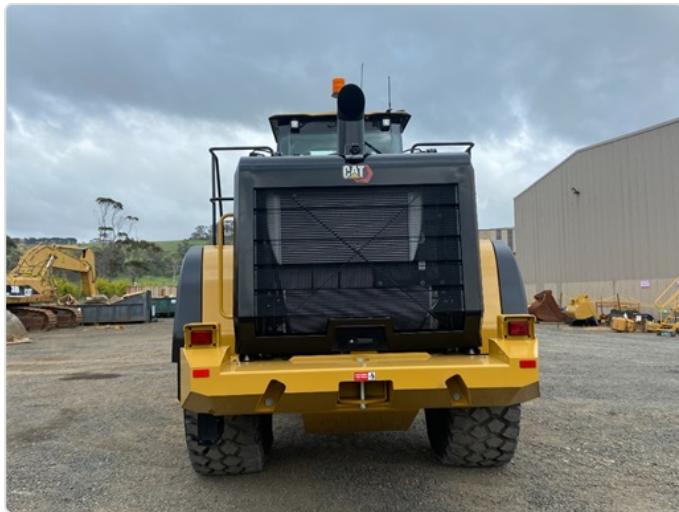
Rear lighting

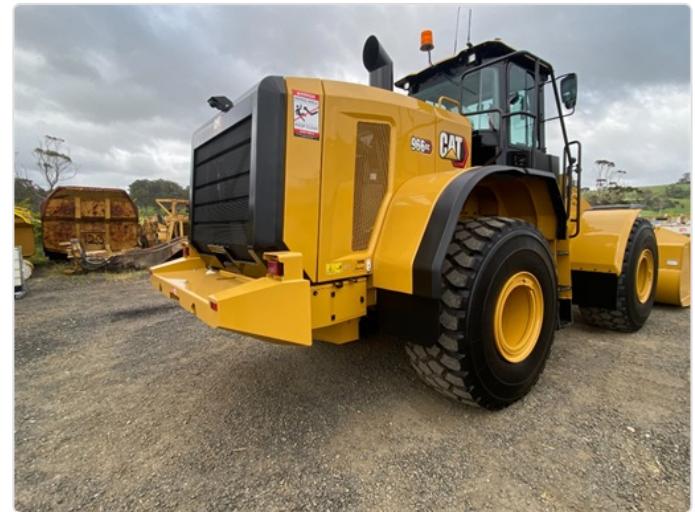
COLLISION	HIGH 22	MEDIUM 15
<b>Risk Treatments in Place:</b> Beacon		
This item of plant is fitted with a safety beacon. This beacon must meet the following criteria at all times whilst this item of plant fitted is in operation - - Is visible up to 200m in all directions (allowing for intermittent obstruction from the plant structure whilst the plant is in operation) - Is fitted in the most appropriate location on machine to maximise visibility without risking continual damage		
NOTE: more than one beacon may be fitted to meet these criteria.		
<b>References:</b> ISO20474-

Beacon fitted to cab roof

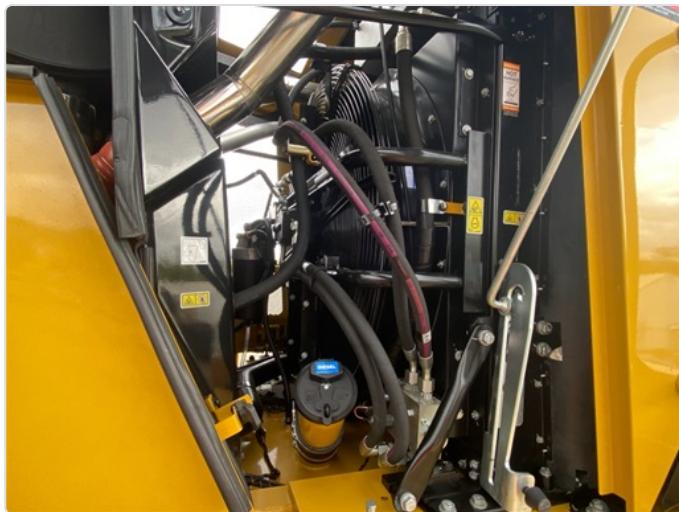
ENTANGLEMENT, SHEARING, BURNS	MEDIUM 14	MEDIUM 13
<b>Risk Treatments in Place: Engine Guard Label</b> The engine fan and alternator belts, pulleys and gears are guarded. These guards have clear legible hazard warning labels re do not open or remove guards while engine is running. These labels must be present, legible and easily seen at all times whilst this item of plant is in operation.

Finger guards around fan

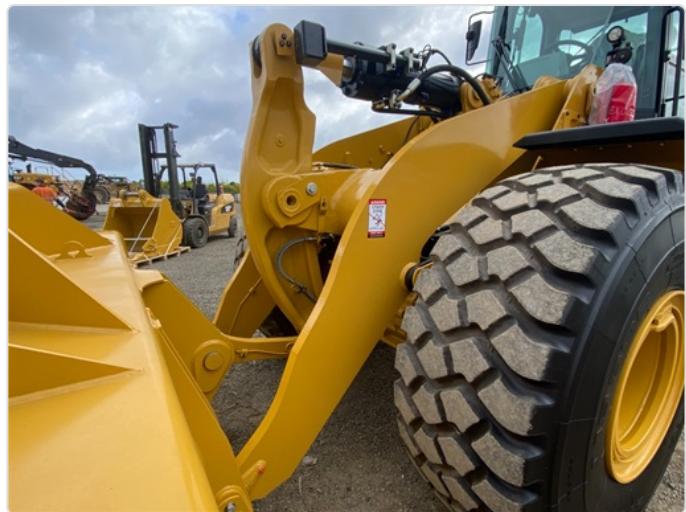
Crush zone decal

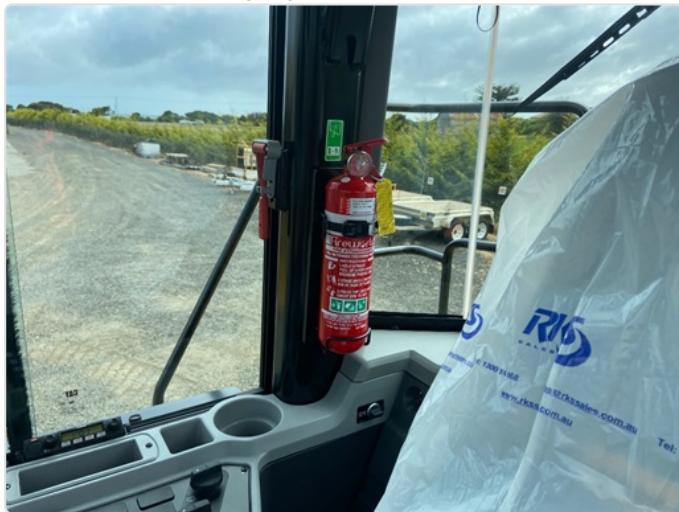
<b>FIRE</b>	HIGH 21	MEDIUM 15
<b>Risk Treatments in Place:</b> Fire Extinguisher		
This item of plant is fitted with an approved and maintained fire extinguisher. Fire extinguisher(s) must be present and fully functional at all times. They must be readily accessible to the operator. Regular inspections must also be carried out in accordance with the manufacturer's requirements and AS 1851 – 1995

Fire extinguisher in cab

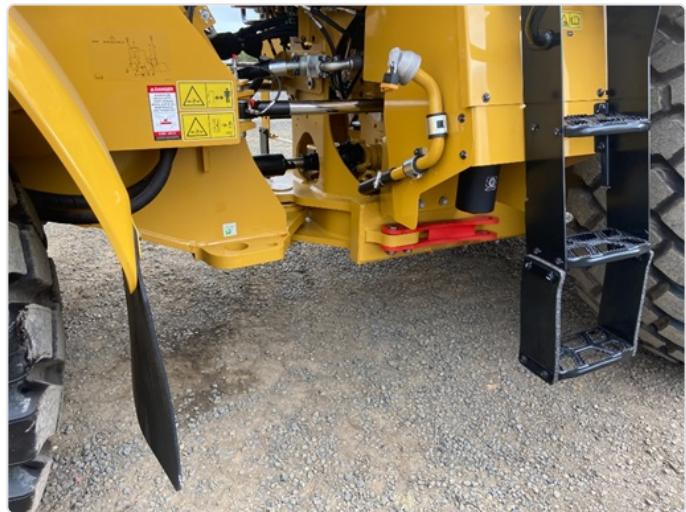
<b>Risk Treatments in Place:</b> Articulated Joint Crush Label		
This item of plant has clear hazard warning labels re: crush zone, keep clear, that are attached to each side of the articulated joint. These must be present, clear and legible at all times whilst this item of plant is in operation.		
<b>References:</b> AS/NZS4024.1201, ISO20474-

Articulation lock and crush zone decals

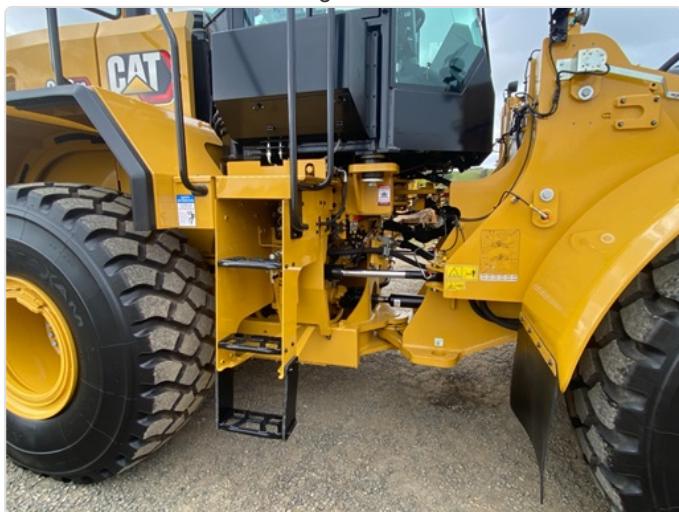
Crush zone decals in hitch

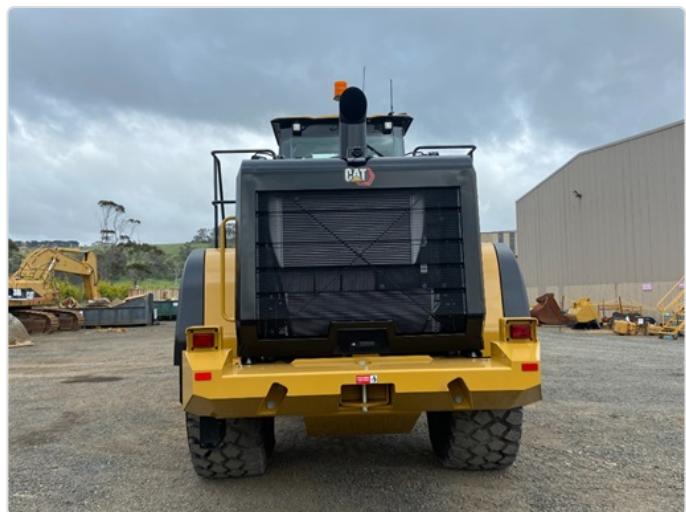
COLLISION	MEDIUM 9	LOW 5
<b>Risk Treatments in Place: Recovery Point Label</b> This item of plant is fitted with a hazard warning label adjacent the recovery tow point which states "Recovery tow point – Read manufacturer's towing instructions before towing". Failure to do so could result in DEATH or SERIOUS INJURY.		
This label must be clear and legible at all times whilst this item of plant is in operation.		
<b>References:</b> ISO31000

Rear recovery point

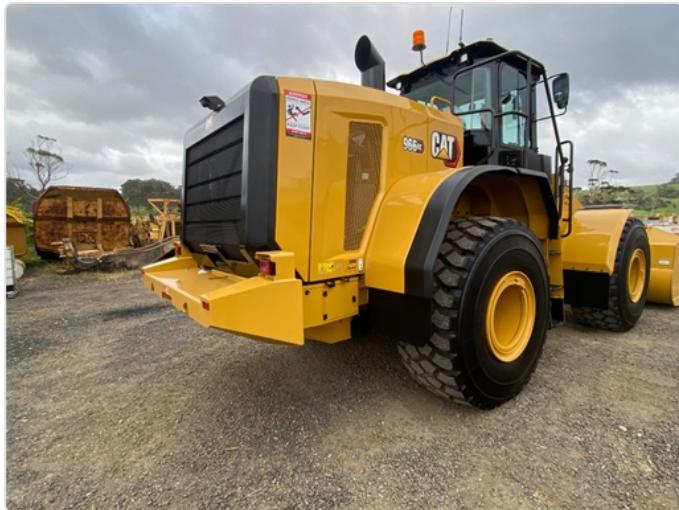
CRUSHING, STRIKING, COLLISION	HIGH 19	MEDIUM 14
<b>Risk Treatments in Place: Tail Swing Label</b> The rear of this item of plant has a hazard warning label re: general plant movement, tail swing, keep clear. It must be present and fully functional and serviceable at all times.		
<b>References:</b> ISO20474-

Keep clear of swing area.

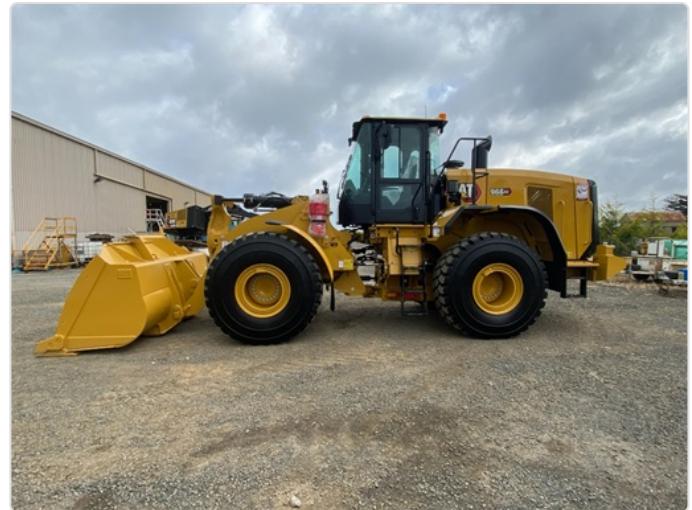
New machine

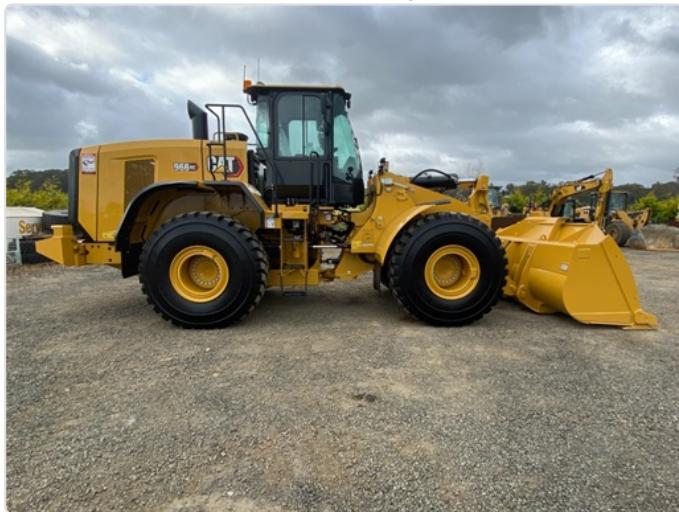
New machine
