| TYPE | Loader, Wheel |
| MAKE | Caterpillar |
| MODEL | 966GC |

| Report Number | WILL 20211206-1607 |

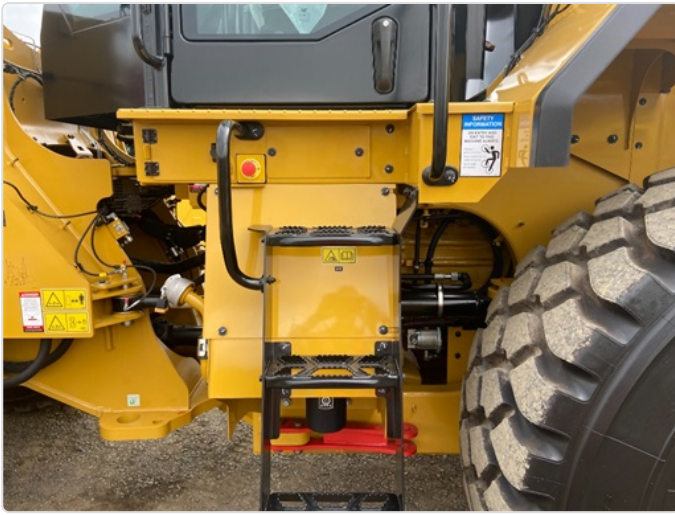
Cab access steps and grab rails L/H

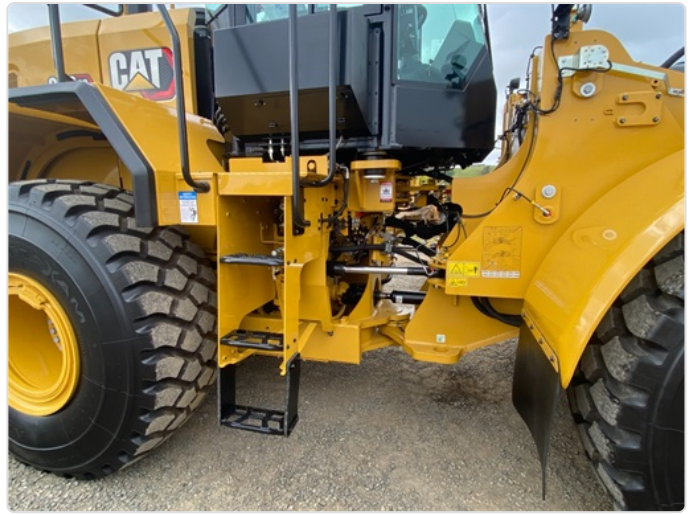
Cab access steps and grab rails R/H

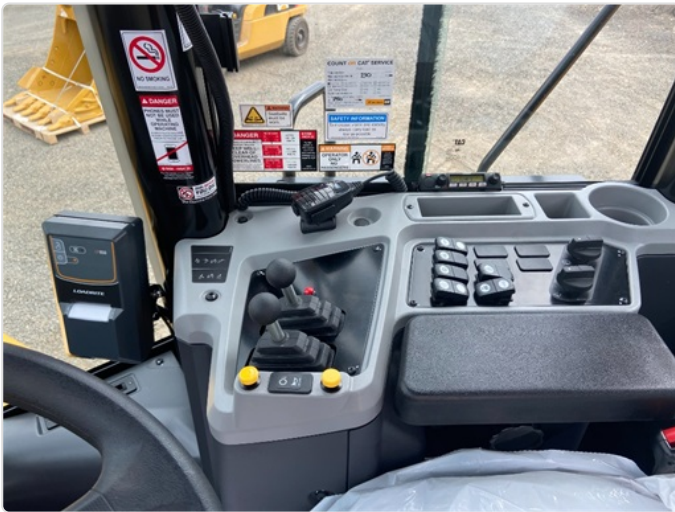
Operator controls

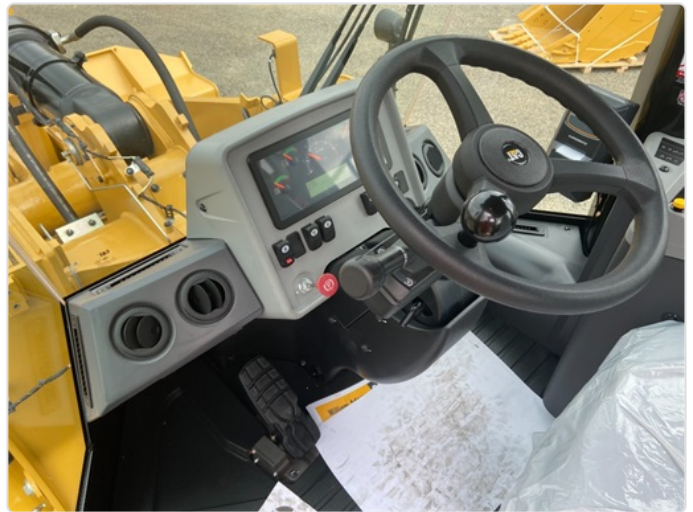
Operator controls

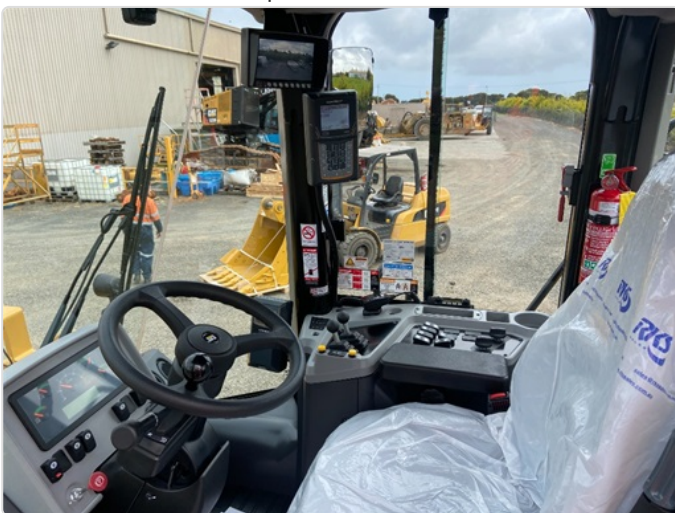
Safety decals in cab

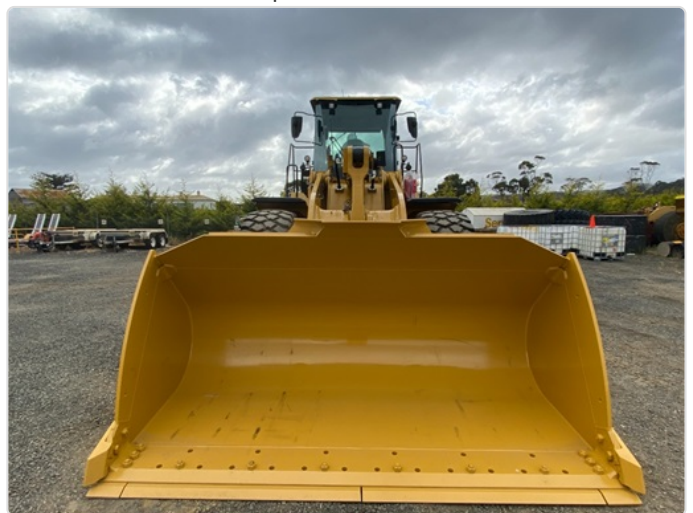
Front lighting

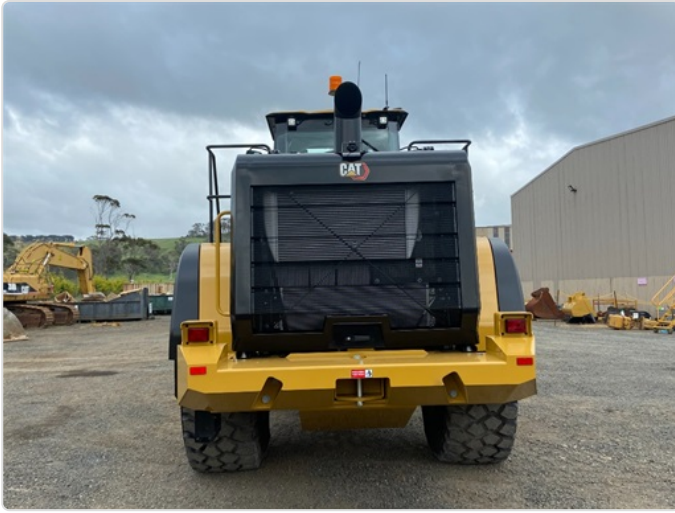
Rear lighting

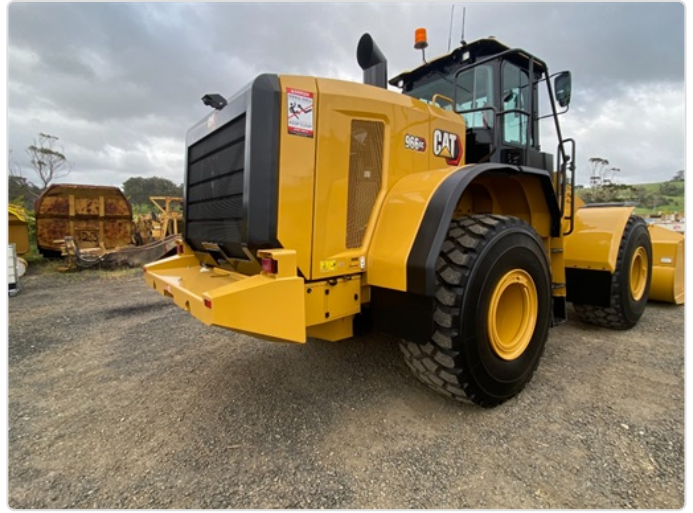
Beacon fitted to cab roof

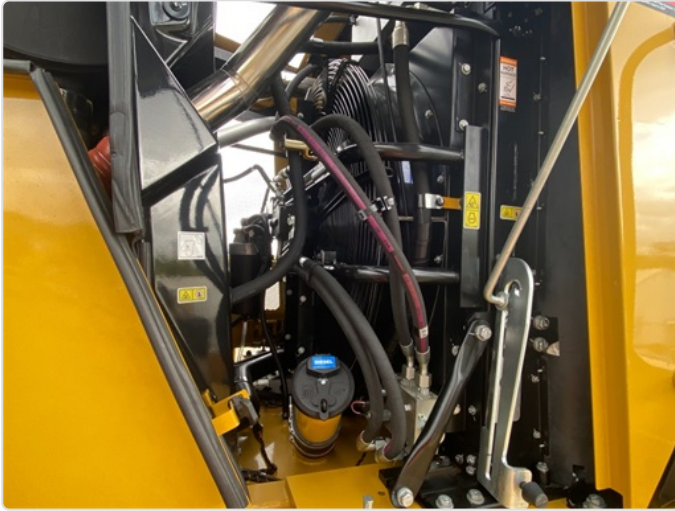
Finger guards around fan

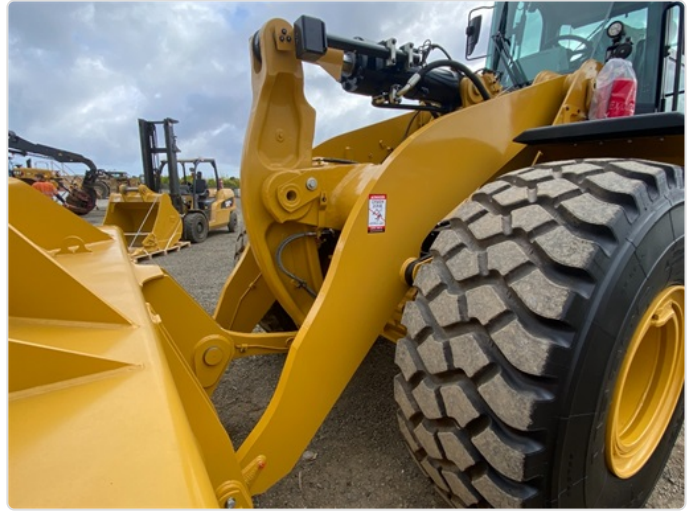
Crush zone decal

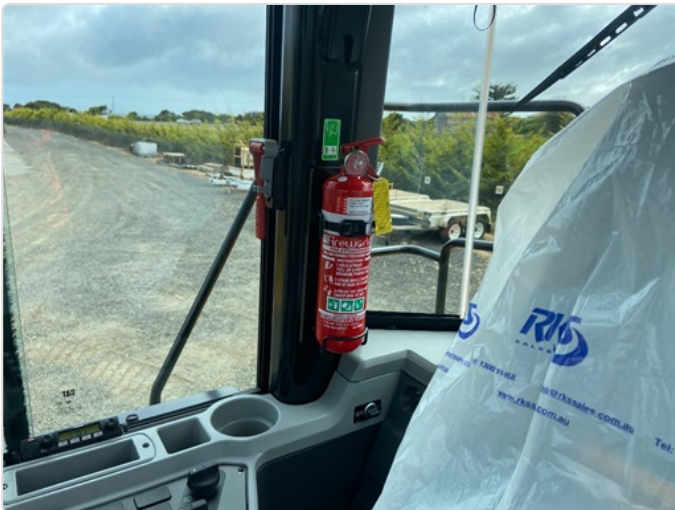
Fire extinguisher in cab

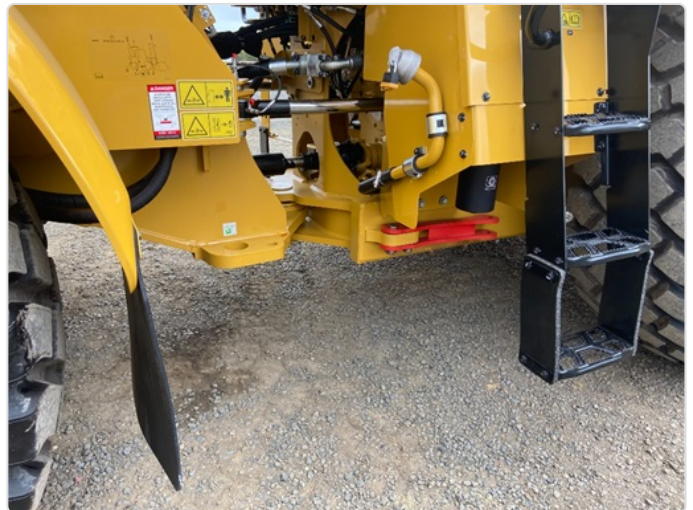
Articulation lock and crush zone decals

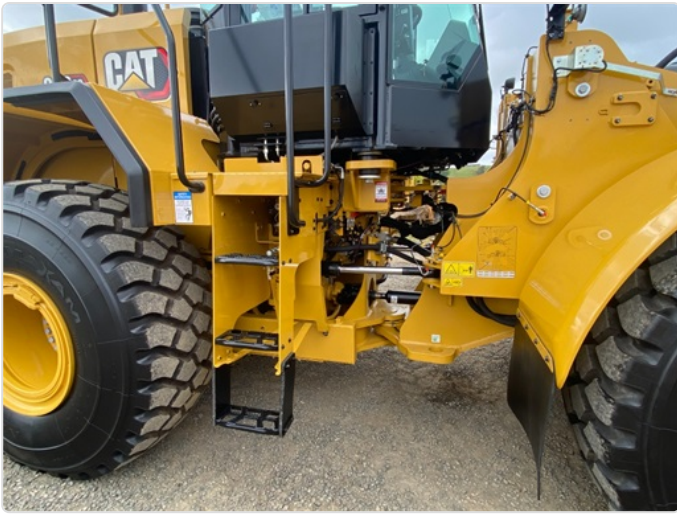
Crush zone decals in hitch

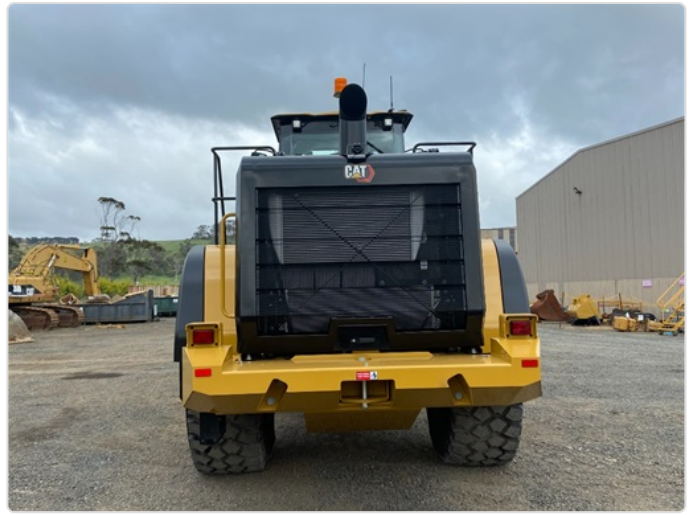
Rear recovery point

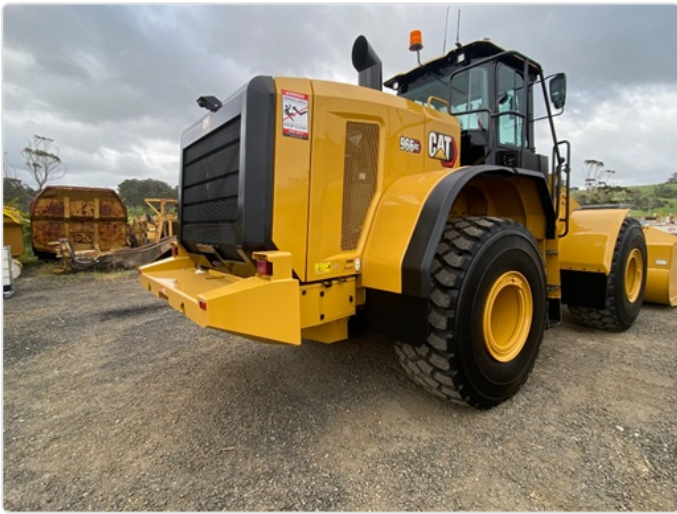
Keep clear of swing area.

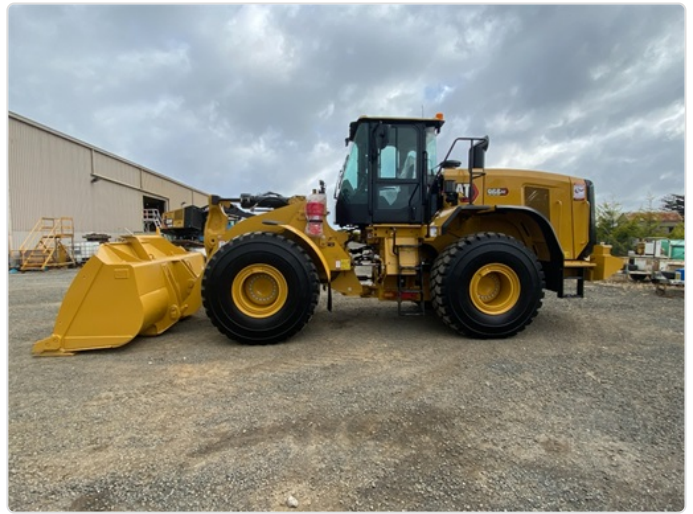
New machine

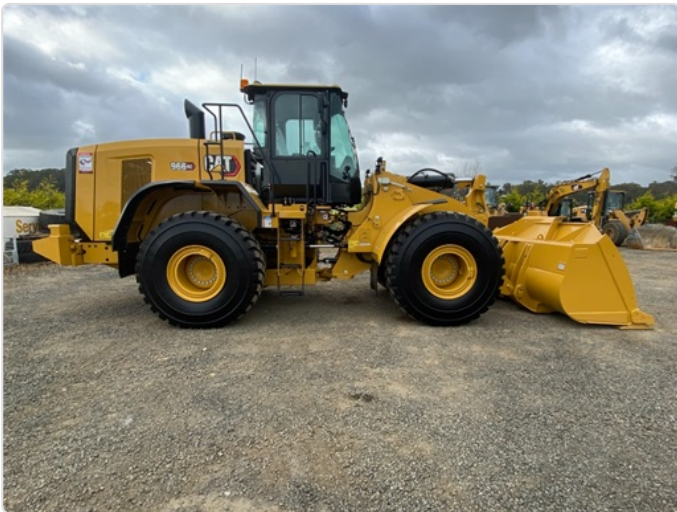
New machine
