TYPE	Excavator - Large (20 Tonne +)
MAKE	Caterpillar
MODEL	330 Next Gen
SERIAL NUMBER	KEL21100

Report Number	WILL 20220306-0936
Date	06-Mar-2022
Created By	Matthew Knowles
Assessor	Matthew Knowles
Assist. Assessor(s)	
Completed By	Matthew Knowles
Owner	New Equipment - Tasmania
Machine Hours	5
Assessment Purpose	Sale
State	TAS

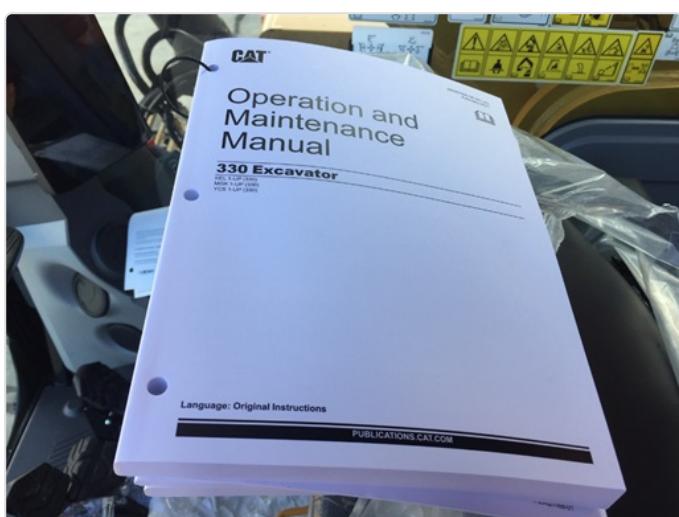
OPERATION AND MAINTENANCE MANUAL.

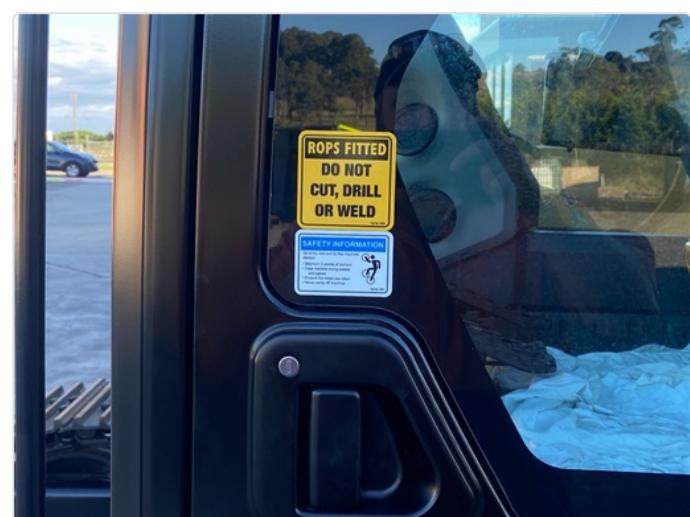
THREE POINT TOUCH DECAL

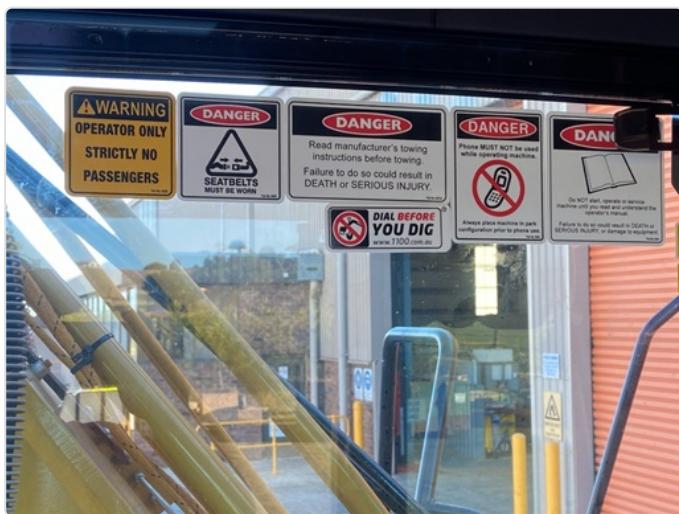
NO PASSENGERS, OVERHEAD POWER LINES, DIAL BEFORE YOU DIG AND NO USE OF MOBILE PHONE DECAL.

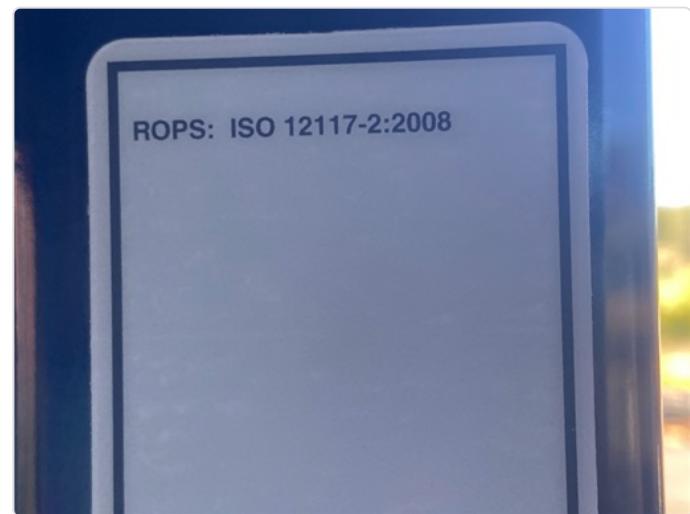
ROPS ISO DECAL.

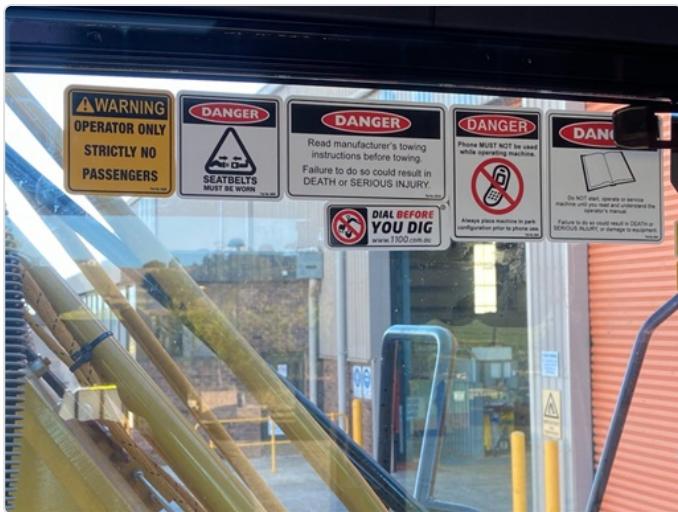
SEAT BELT MUST BE WORN DECAL.

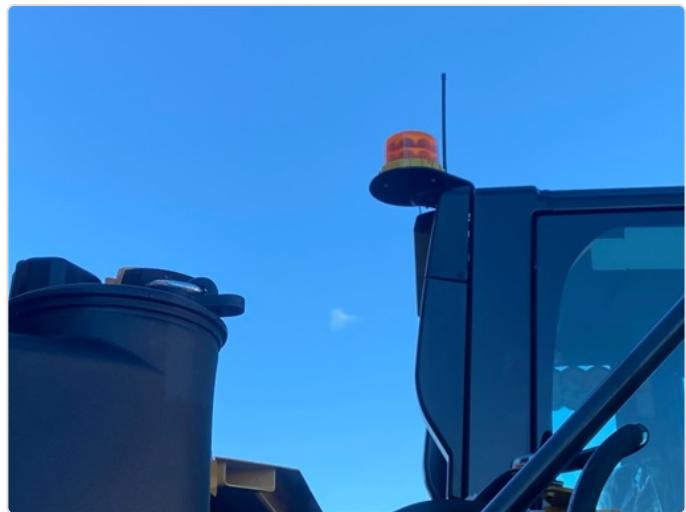
ROTATING SAFETY BEACON.

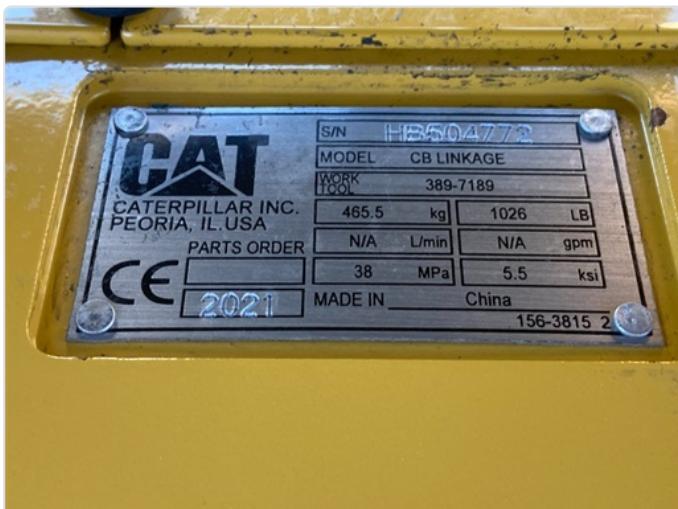
HITCH ID PLATE.

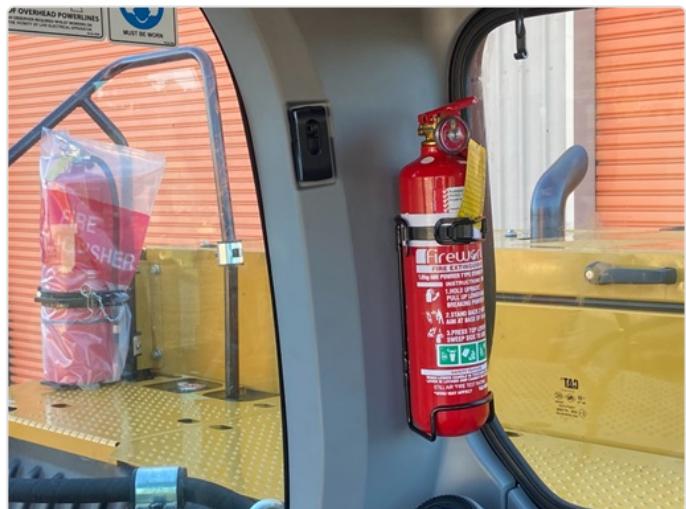
1 KG FIRE EXTINGUISHER.

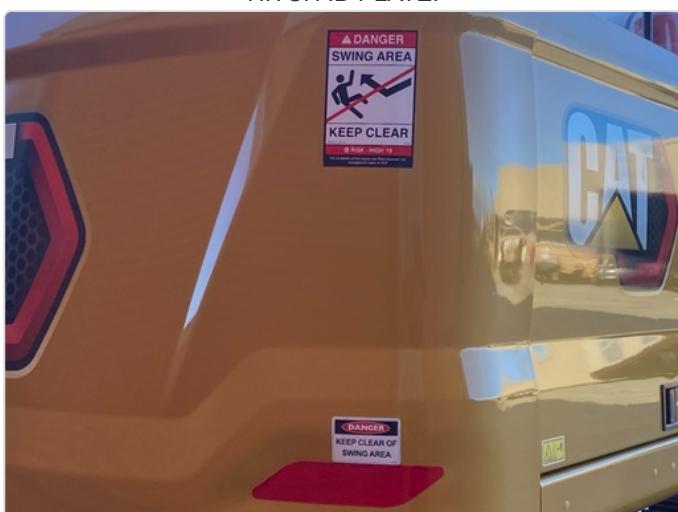
KEEP CLEAR OF TAIL SWING RH SIDE

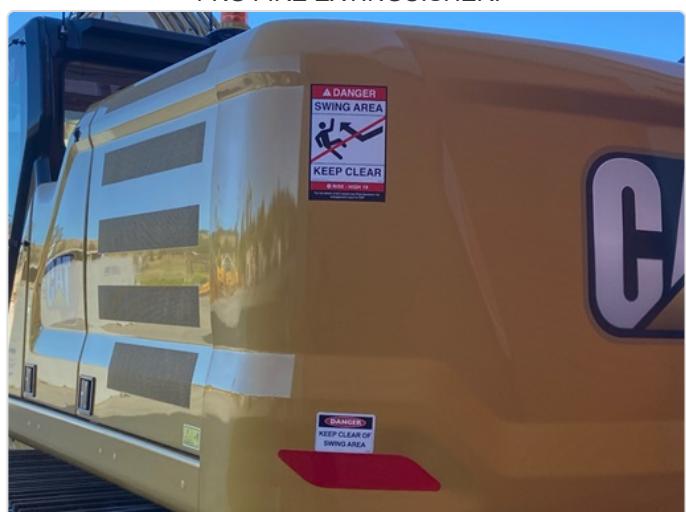
KEEP CLEAR OF TAIL SWING LH SIDE.

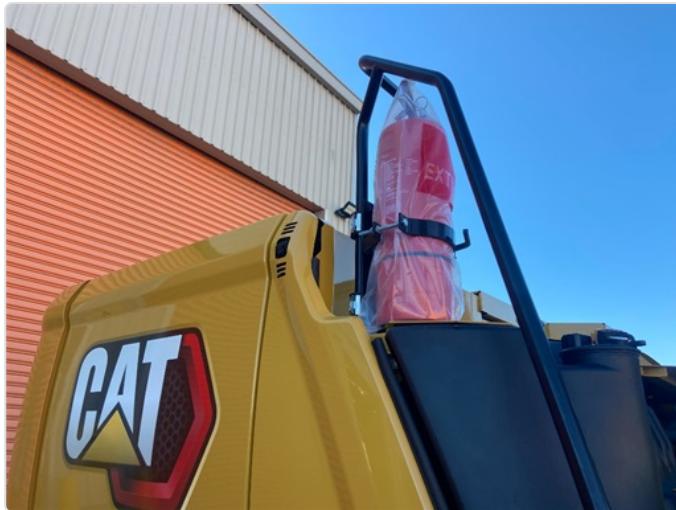
9KG FIRE EXTINGUISHER.

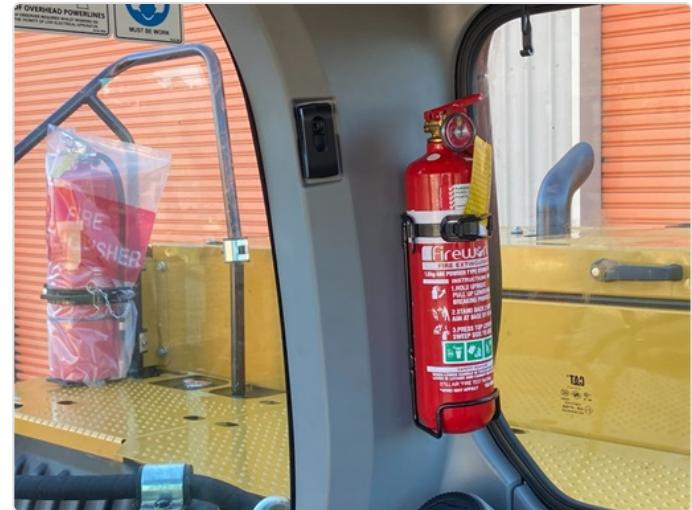
1 KG FIRE EXTINGUISHER.

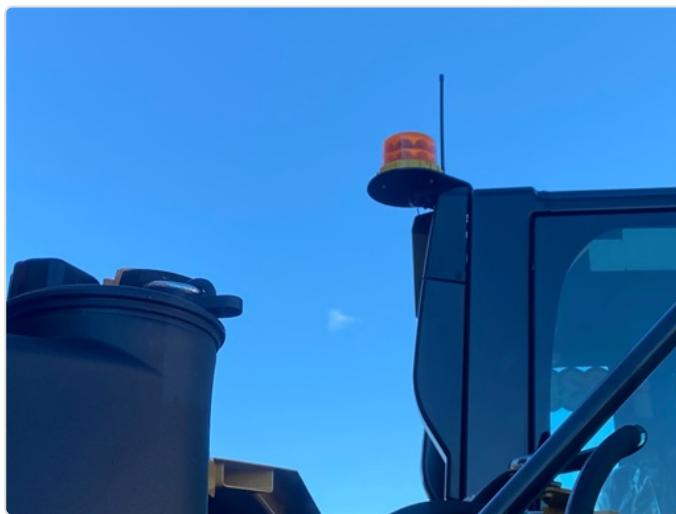
ROTATING BEACON.

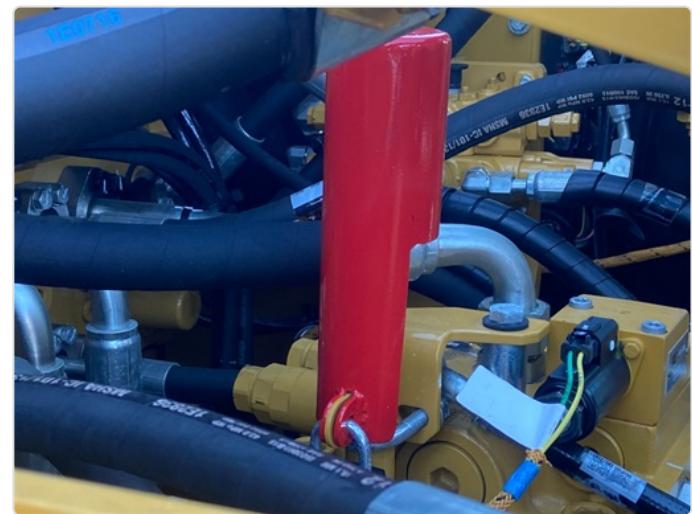
SWING DIPSTICK TUBE LOCK.

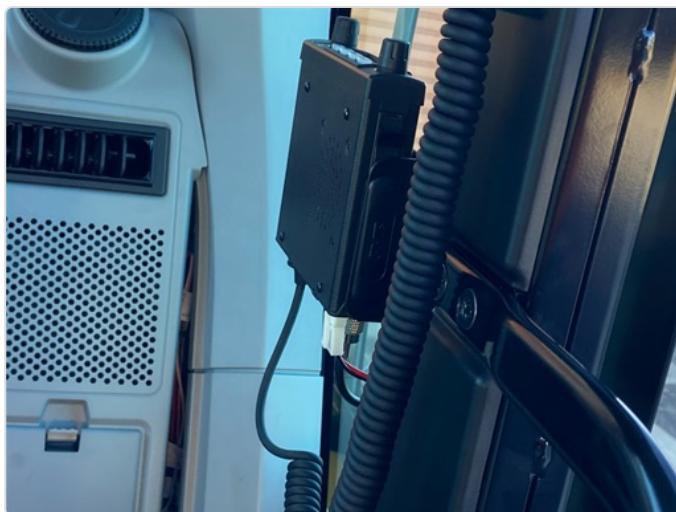
UHF RADIO.

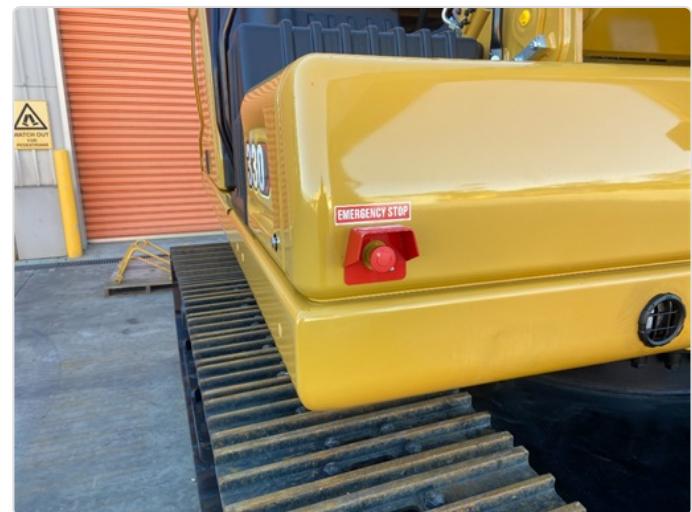
OFF SIDE GROUND LEVEL EMERGENCY SHUTDOWN.

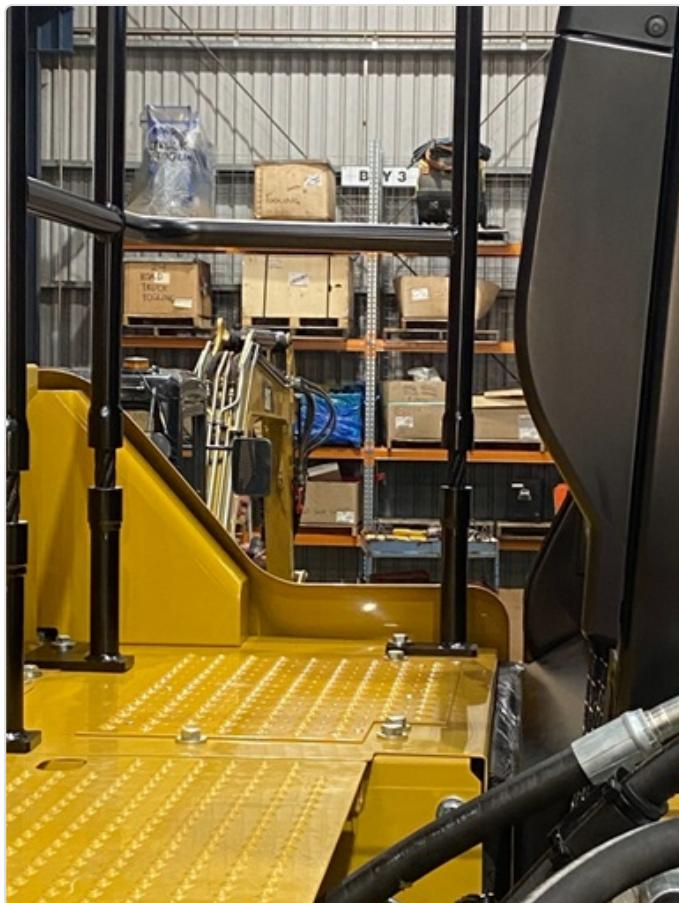
CAB HANDRAIL.
