RISK MANAGEMENT REPORT

TYPE	Excavator - Large (20 Tonne +)
MAKE	Caterpillar
MODEL	330 Next Gen
SERIAL NUMBER	KEL40155

Report Number	WILL 20260114-0513
Date	14-Jan-2026
Assessment Purpose	Sale
State	TAS
Created By	Matthew Bishop
Owner	CAT Rental
Assessor	Matthew Bishop
Assist. Assessor(s)	
Completed By	Matthew Bishop
Machine Hours	7

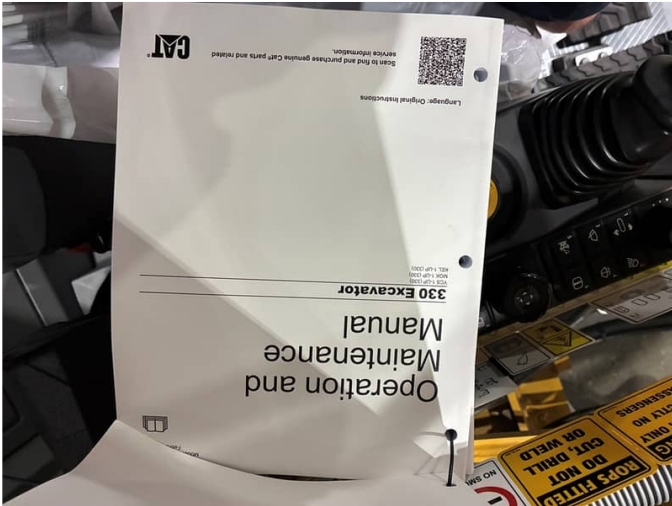
ops manual

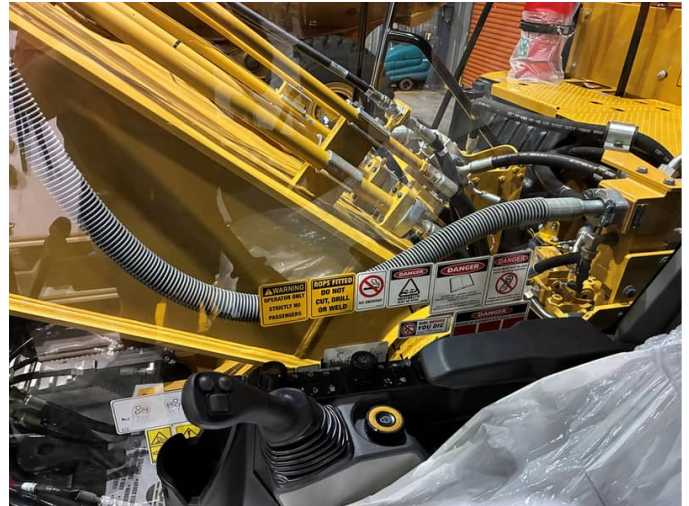
Warning decals

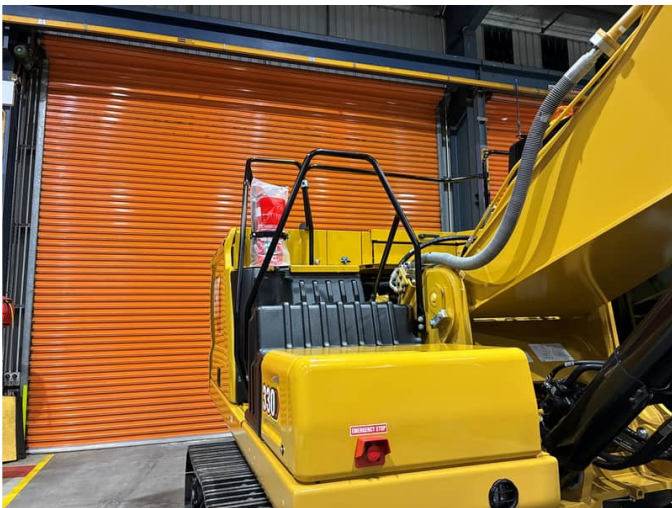
Front R/H emergency stop

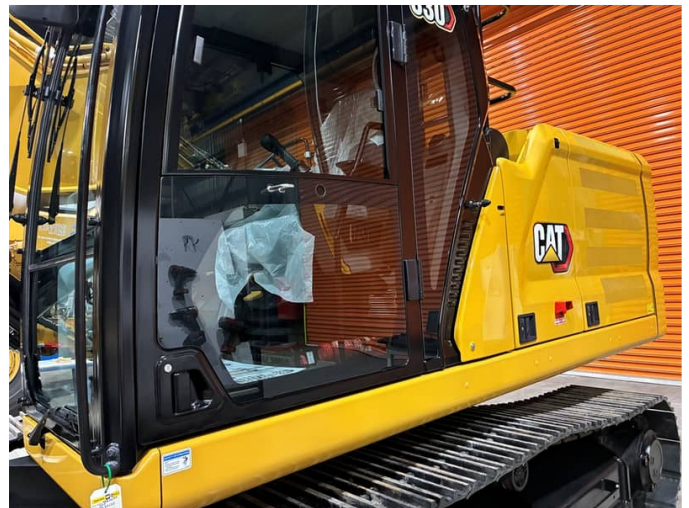
L/H emergency stop

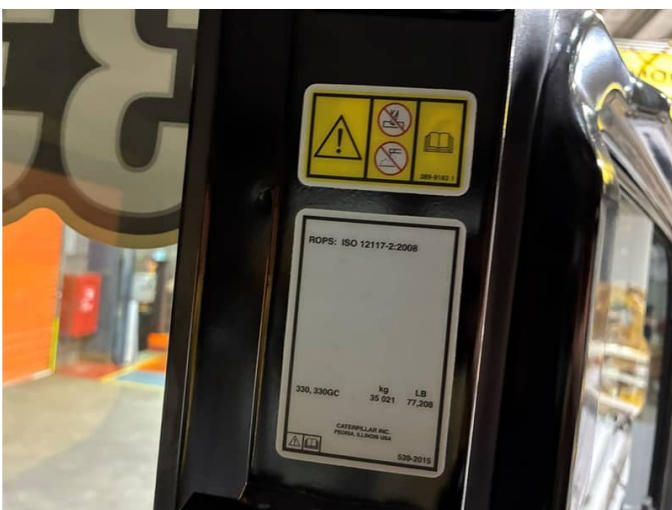
ROPS plate

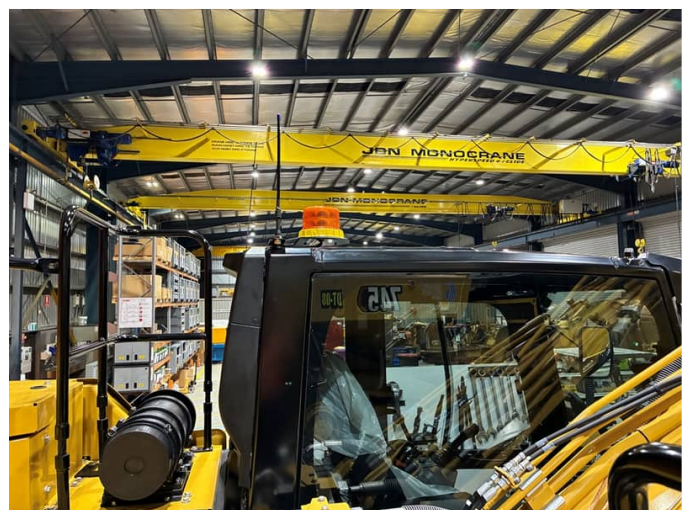
Flashing beacon

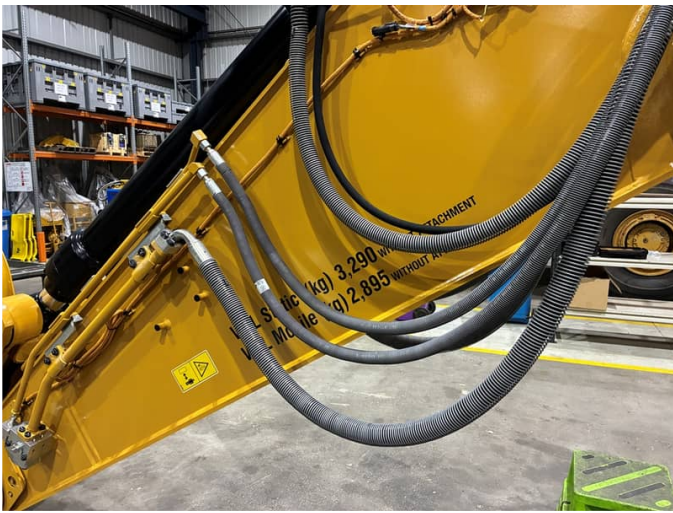
SWL decals

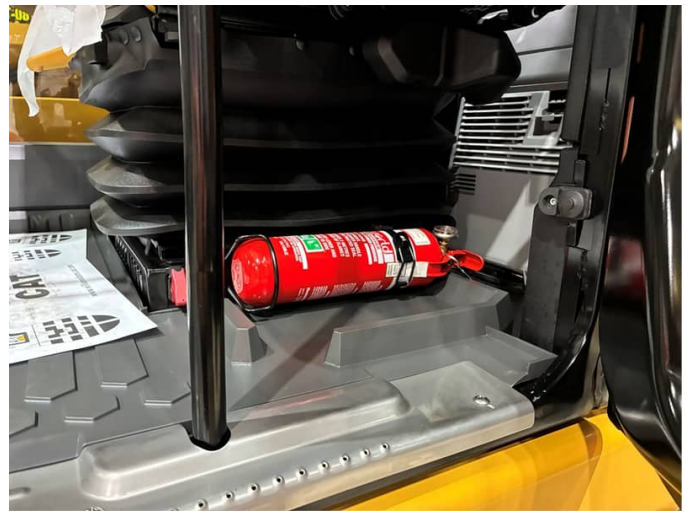
1kg extinguisher in operator compartment.
